Date Issued: 01st December 2017

ICAM 50: Investigation 798345 - Broken HV Earth on SWER Transformer, Lawrence.

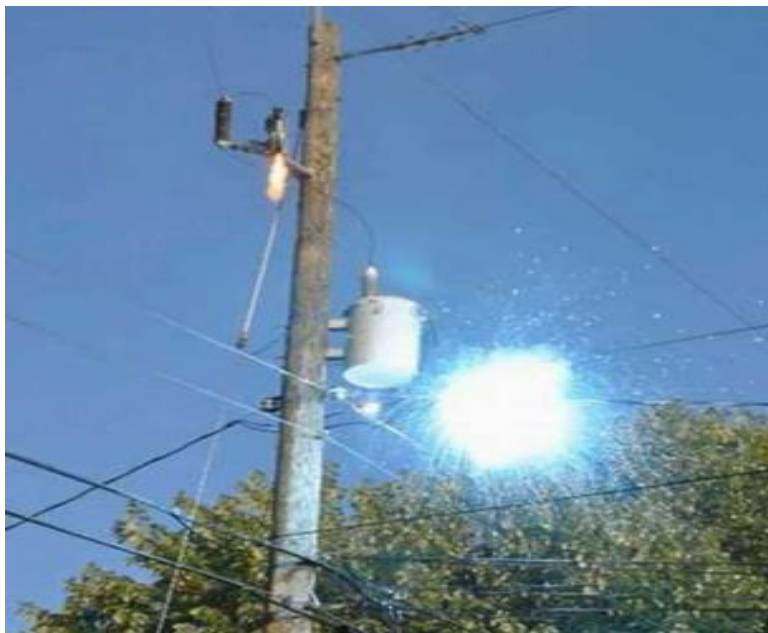
A PowerNet Faults person was dispatched to Transformer 2170 after receiving a report from the landowner of electrical disturbance at the site. When the faults person approached the site, he saw the earth wire was not connected and was arcing onto the pole and possum guard. The faults person did not approach the pole but went and isolated the SWER line from isolators at another location.

The potential for serious injury to anyone approaching the pole at this 11kV E/R site was extremely high. If the Faults person or landowner decided to investigate the faulted equipment, they would have put their personal safety at risk due to the step potential risk with the faulted electricity at this site. We care about our workmates and the public and never want this type of event to happen to anyone.

1. Replace temporary fault repairs at TX 2170 with a new earth installation.
2. Check the condition of other SWER Transformer sites of similar vintage and sites on the feeder where the fault occurred. Check the condition of earths and arrange immediate repair to earths found in poor condition.
