# SAFETY ALERT

**Subject:** Trip mechanism failure on ABB Safelink ring main unit (RMU).

**Date:** Wednesday 2 November 2016

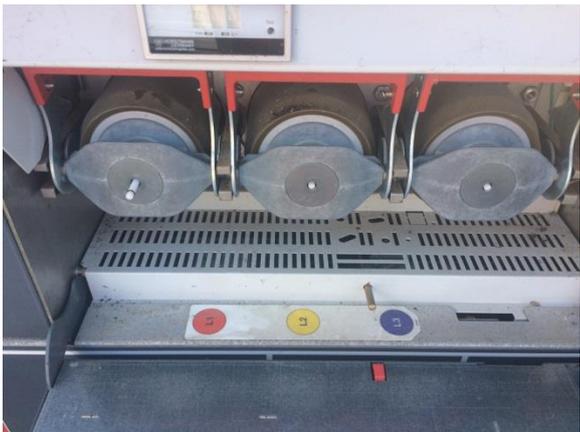
An 11kV cable strike by a contractor caused the fuse to blow and striker to operate (see picture below). However the trip mechanism of the RMU failed to operate correctly, in that the switch indicated tripped but was still closed. This resulted in the cable and transformer still being live. The failure is to be further investigated by ABB to determine the root cause.

The fuse and striker operated normally.

- Treat fuse switch trips as live until proven, and earth switch closed.
- Test the LV side of the transformer to determine if the supply is isolated or not.
- Keep contractors and the public clear until the cable has been isolated and earthed.

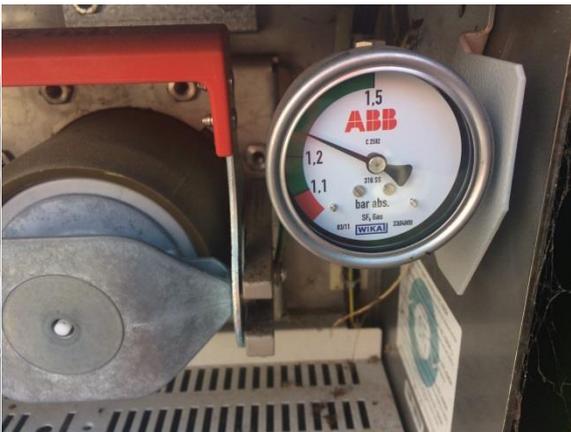
The RMU “appeared” to be in good condition.
