Henderson ODID – Failure in Bus Section Cable Box

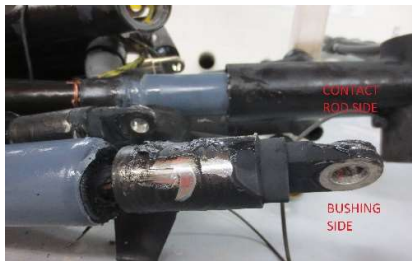
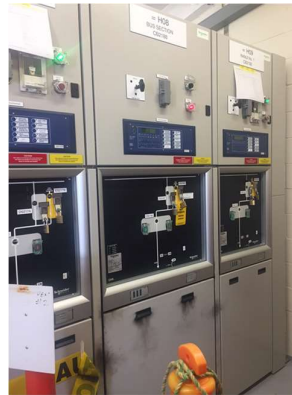
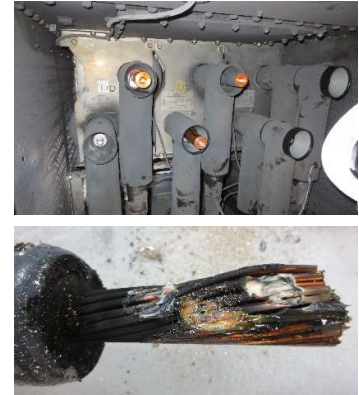
This is an update alert to the incident that occurred on 17th November 2016, where a flashover occurred in the cable box of the new bus section panel for the Henderson Outdoor Indoor Project.

- The interchange of copper contact rods of different lengths between different cable termination kits (10mm difference)
- The incorrect longer contact rods used in the termination allowed the termination to have an air gap which compromised the insulation.
- It cannot be determined how or when the interchange of parts occurred, but most likely on site when the kits were first opened to completion (4-6 weeks).

- All damaged equipment replaced; new termination kits and bus section cables, and all bushings replaced on the new switchgear.
- Full ICAM investigation completed by consultant, and reviewed by all involved parties
- Root cause, learning and recommendations to be shared and actioned.
- Project since then has been able to get back on track, and successfully migrated half of the feeders.

- Kit Installations to be clearly marked, securely stored, and completed as quickly as possible without extended down time to minimise risk of interchange.
- Ensure critical component dimensions are supplied with installation instructions
- Update specifications and documentation to include relevant tests and check off items - i.e. visual/feel checks of installation, and ensure appropriate dimension measurements have been made.
