## *Safety Advice 12-2013 (May)(NZ)*

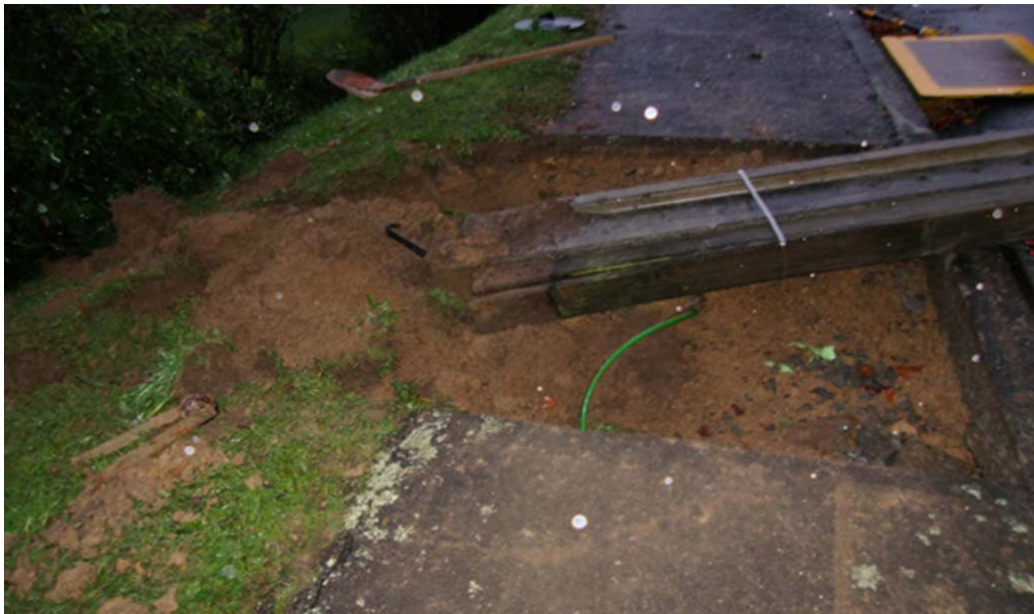
The following Safety Advice 12-2013, outlines an incident where a Low Voltage concrete power pole has fallen across an urban street during the night. A preliminary investigation has determined that the pole failed as a direct result of a hole adjacent to the pole, including removal of concrete footpath, which was excavated by Contractors undertaking Ultra-Fast Broadband infrastructure installation in the location. The excavation at the pole was left open overnight with no alternative or additional support of the pole. The surrounding ground which remained supporting the butt of the pole was weakened by overnight rain, and the pole, together with the LV conductors fell across the road close to a bend on a hill. The LV conductors remained live when the pole fell to the ground and were isolated by the repair crews when they arrived on the scene following a report of the incident by a member of the public.

No assistance or guidance from the Network Company was sought and no Close Approach Consent was requested for the location prior to the works being carried out. Thankfully no one was injured and no property damaged as a result of this pole failure. The incident highlights the significant risks to public safety which can be associated with the roll out of the UFB project and raises questions over the effective application of site safety management and safe excavation techniques when excavating around Electricity Network assets.
