## Lessons Learnt – LL043 Leg Injury

Date of issue: 03/02/2015

Incident	Description				
Date of Event	04/11/2014				
Date of Event	04/11/2014				
Location	Kaikohe to Kaitaia 110kV Transmission Line (Top Energy Project)				
Time	18:30 approximately  Crushed leg				
Injuries/Damage sustained					
Event Description	Staff completing a Pi Pole replacement live line moved the ladder from the outside conductor to the middle conductor. The staff member seated on the suspended horizontal ladder was guiding its placement and had a leg caught in the "pinch point" between the ladder and Pi Pole step bolt when guy ropes passed the pivot point.				
	The state of the s				
Initial Actions Taken	The job was stopped for medical assistance and recovery and the site made safe before completing the job to maintain system security.

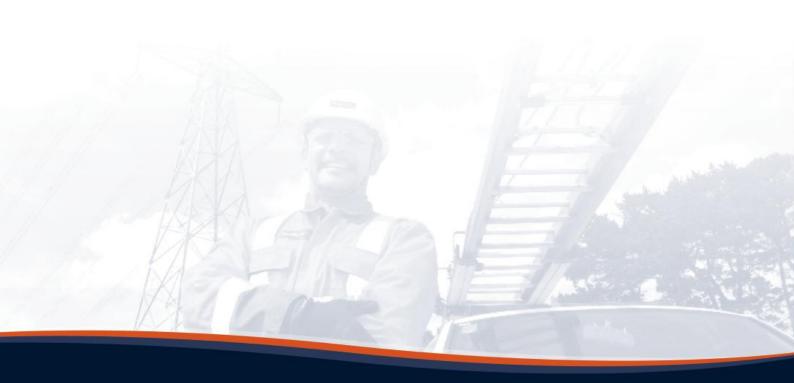
***************************************
Key Learnings	<ul> <li>There was not enough time made available for the planning and preparation of the site and verification that the procedure was suitable for this application.</li> </ul>
	<ul> <li>The team were not experienced enough with this type of operation to be able to recognise the additional risk due to a change in environment that would restrict the angle of pull on the tag lines.</li> </ul>
	<ul> <li>Failure to follow basic training and good working practices i.e. while moving ladder (man sitting), safety observing and ensuring an effective means of communication with work party members</li> </ul>
	<ul> <li>Ordinary guy ropes which can be dragged along the ground should have been used rather than live line ropes as this would have freed up both hands giving greater control of the ladder.</li> </ul>
	<ul> <li>The standard ladder base support was twisting and not a good fit for the steel poles and a steel on steel situation existed. At 90 degrees to the ladder base there is substantial leverage on the ladder base and the bottom of this base is inclined to move.</li> </ul>

Please Note: The Live Line Procedure has been reviewed externally, updated and communicated to the team/s.
Released by:	Janine Wagstaff - 0274595660
