# FIRST ALERT

**Date of Incident:** Tuesday 1<sup>st</sup> March 2016

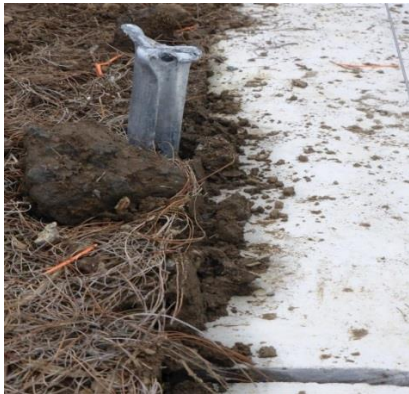
**What happened?** A fencing contractor was driving an earth stake into the ground within the Penrose substation but outside the Switchyard. The stakes were driven to provide an earth for the perimeter security power fence.

The earth stake damaged and tripped a Vector oil filled 33kV feeder cable. No one was injured and the area was cleared and coned off. A detailed investigation has been initiated.

An initial recommendation is that until further notice, the practice of driving spikes or pegs for earthing within Transpower substations should cease.

People working in Transpower sites are also reminded that they must never assume the position or depth of underground services as these services may be installed at any depth below the surface.
