Safety Advice 14-2013 (May), (NZ)

INJURY TO A MEMBER OF PUBLIC

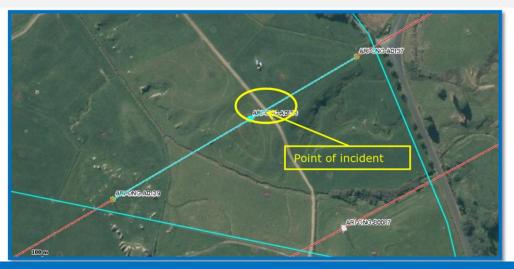
A member of the public received a head injury (a cut above the eye and a hit to the back of his head) when he came in contact with a conductor which had been lowered across a farm track as part of pole replacement works.

As the Landowner drove up a farm access track the conductor struck the passenger who was standing on the deck of the utility vehicle. The lowered conductor was de-energised. It was, however, unmarked and not managed at the accident site.

- The responsibility of ensuring the safety of the general public at all work sites is critical. Hazards created by the work outside the sphere of the work site must be carefully considered and managed to ensure no one is exposed to hazardous risk, or in the worst case, injured.
- SM-EI Part 1 and Part 2, section 3 Work and Access Control and SM-EI 1.406 Safety of persons other than the work party, clearly outline the measure necessary to ensure controls are in place to prevent harm to employees and others in the vicinity of the works.
- Please review your worksite safety plans to ensure full control measures are in place at all worksites including where works may impact outside the immediate worksite area.
