Mangahao 33kV Yard Asbestos Contamination

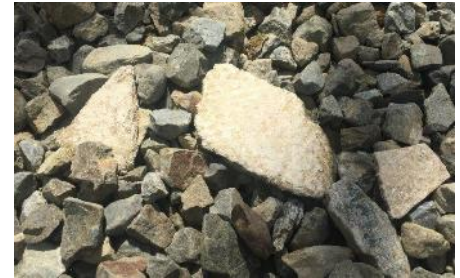
An asbestos assessment was carried out at Mangahao substation on 02/03/2017. The assessor found significant quantities of asbestos board shards within the yard metal. The assessor is confident the fragments contain asbestos, and a sample has been taken for laboratory testing.

The majority of the asbestos material is located within the elevated northern half of the site, with the most heavily impacted area covering approximately 200m².

It appears this material has been in-situ for a long period of time. The asbestos material is very weathered and is in poor condition, with exposed fibres in many cases. The material should **not** generate measurable amounts of airborne asbestos (i.e. <0.01 fibres/ml of air) under normal site use.

- Make necessary personnel aware of the issue.
- Stop all personnel from entering the site until further notice as a precautionary measure.
- Cancel all work that was planned in the 33kV yard for the upcoming 2 weeks. Ongoing restrictions will be reassessed as additional information comes to hand.
