## *Safety Advice 16-2013 (May) (NZ)*

### Transformer HV Bushing Fault

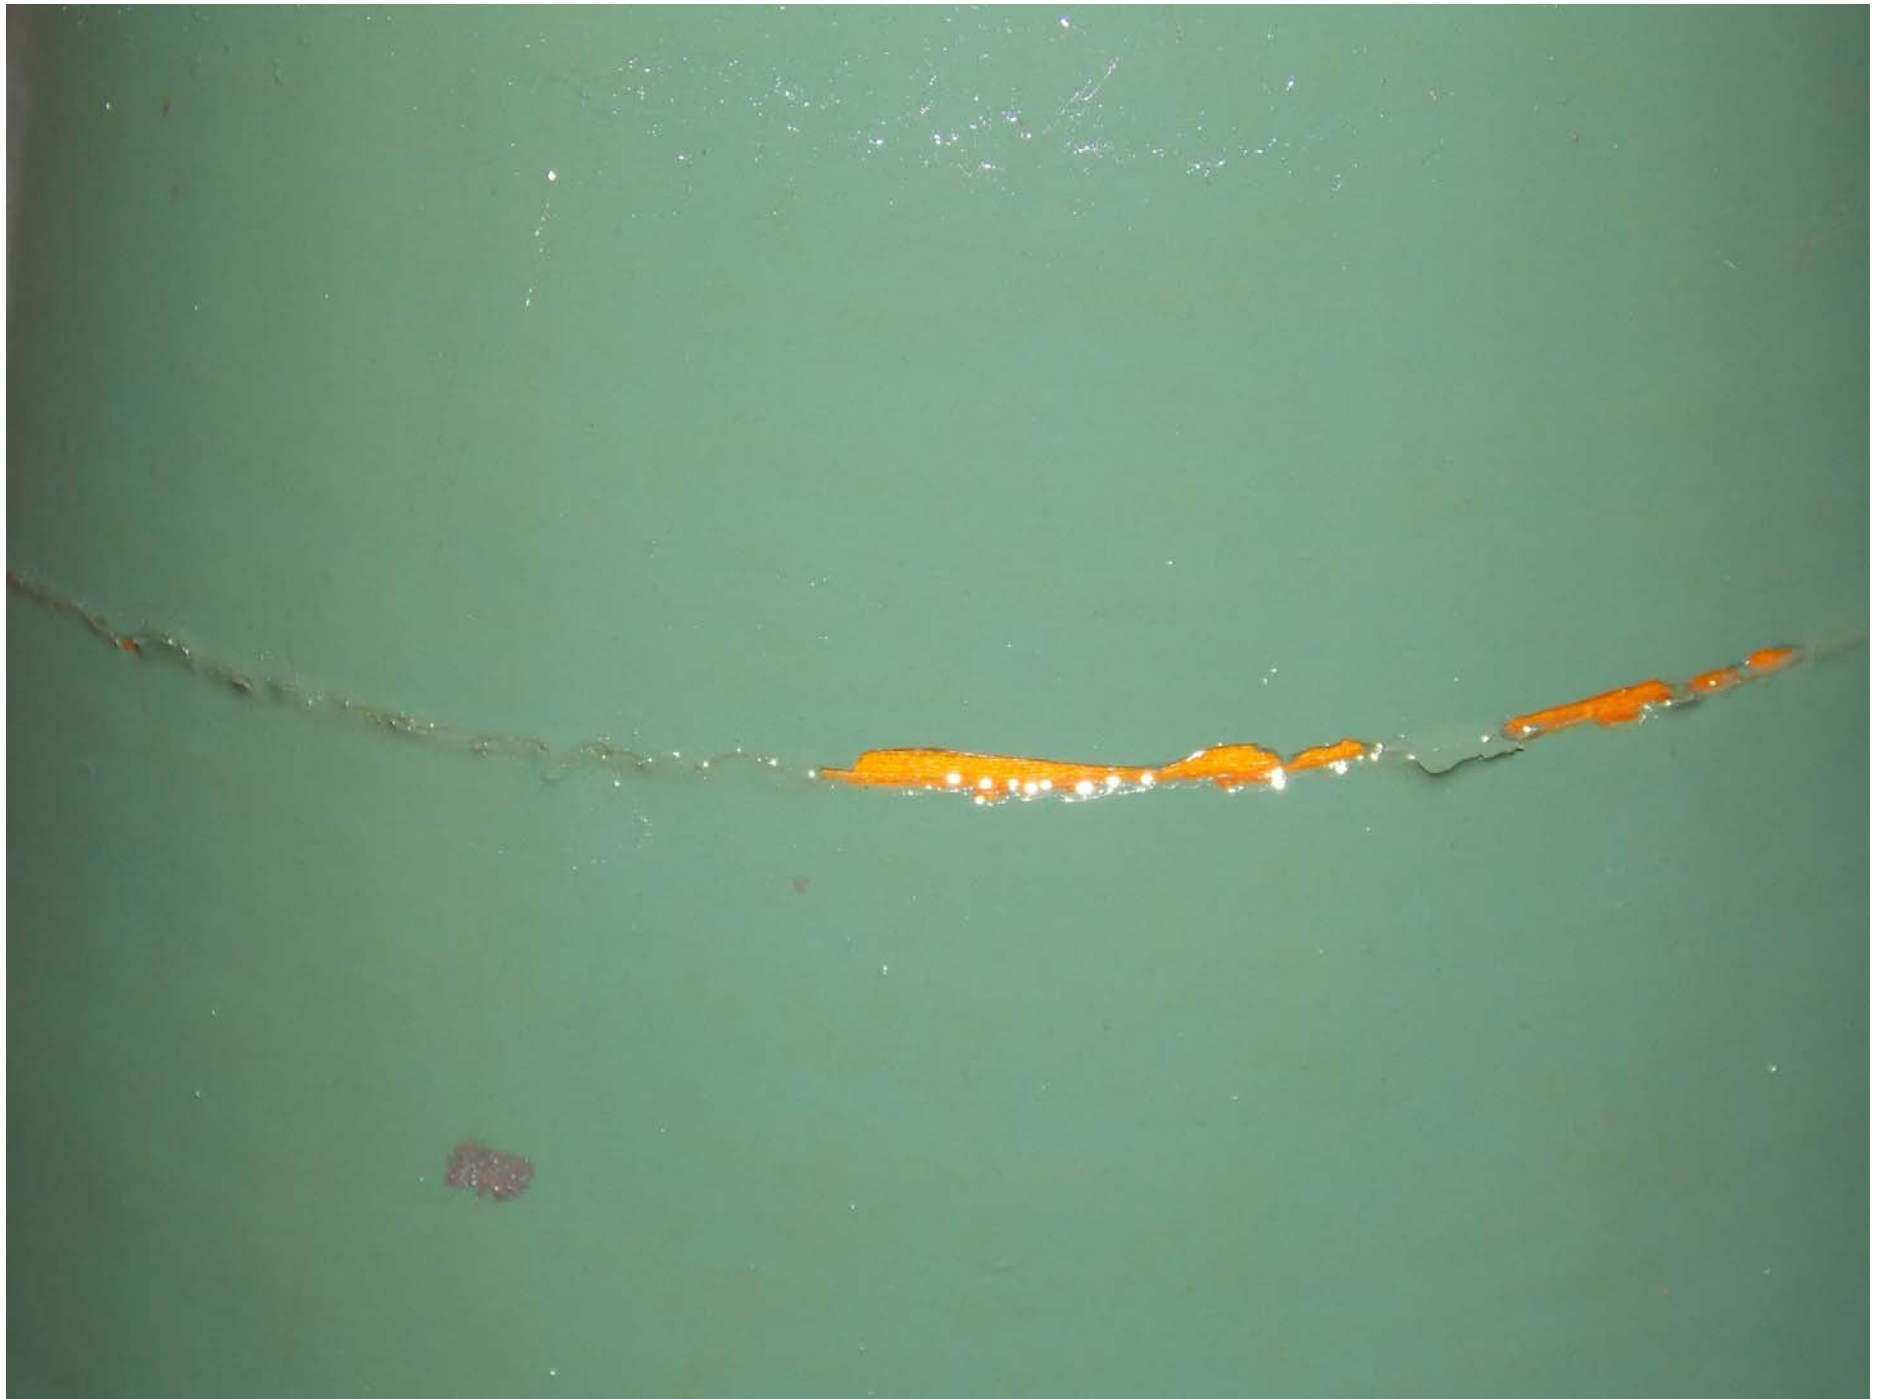
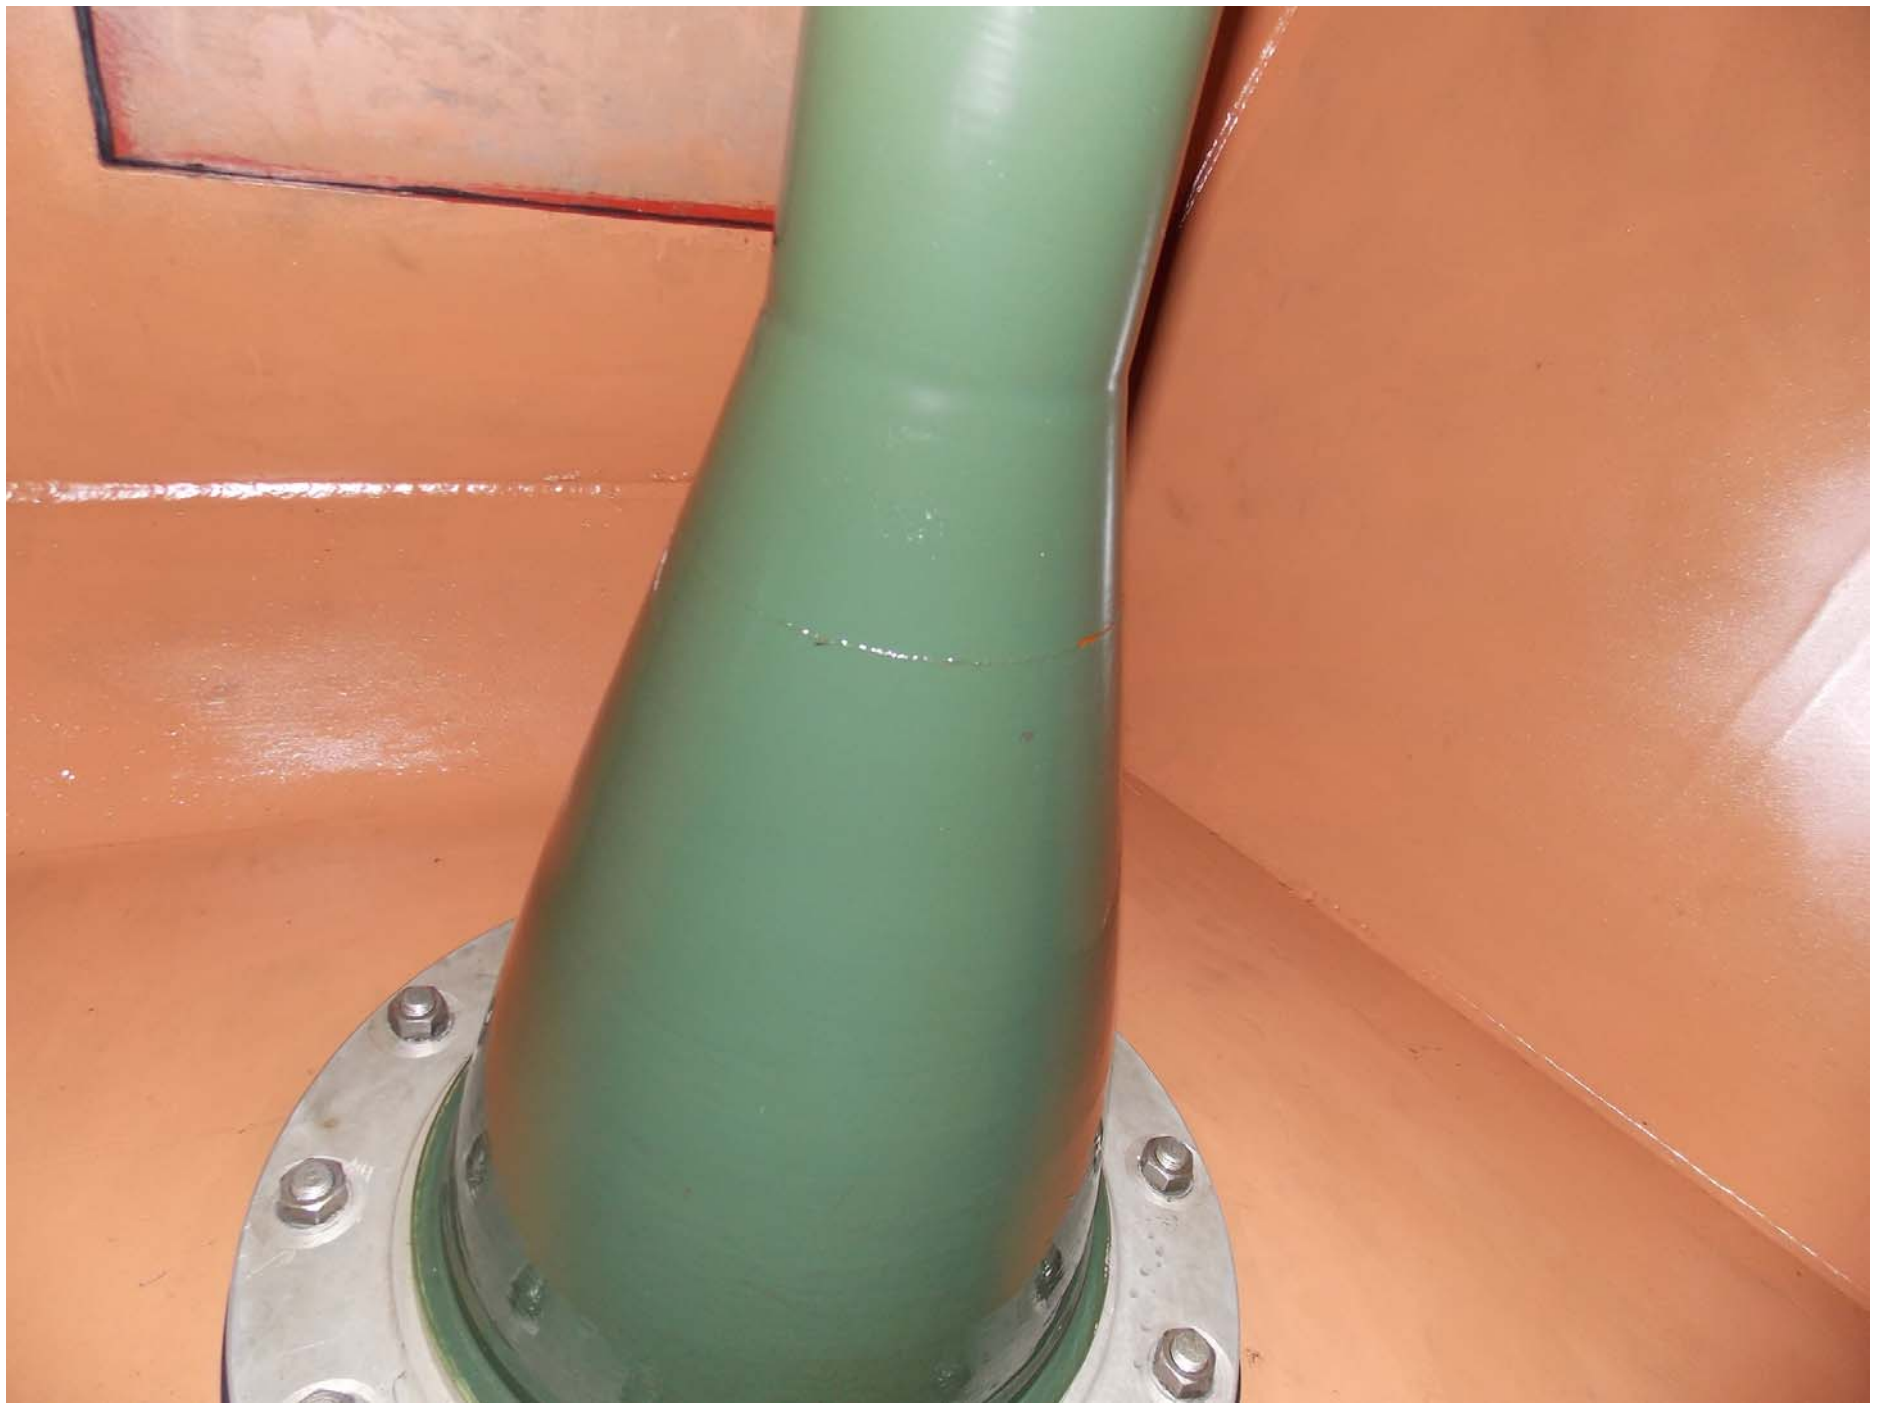
Asset owners with high voltage, resin bonded, oil-oil transformer bushings are advised to visually inspect both sides of the bush for concentric cracking that could indicate the bush has delaminated. The following photographs show examples of the type of cracking. The matter is being investigated and an update will be provided as additional information is made available
