TRANSPOWER

FIRST ALERT

CBF and BZ testing causes LOS in South Island

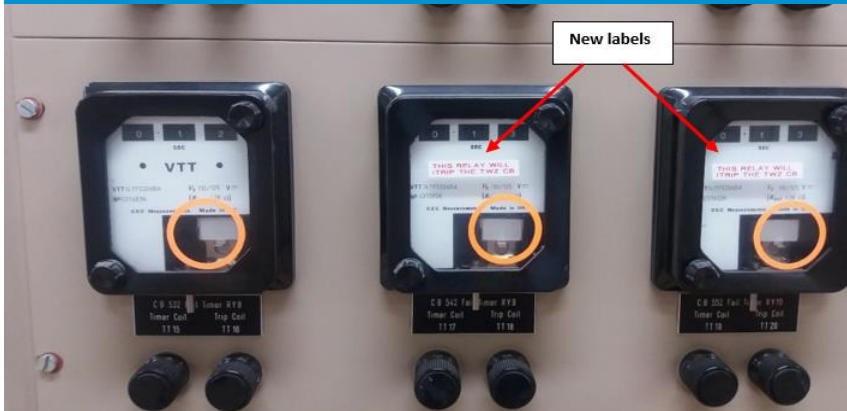
Figure 1- New labels attached post-event warning technicians of i-Trip

- Due to the CBF and BZ test/isolate/service switches not isolating all protection circuit outputs during testing, an I-trip was sent to the Twizel end of the circuit and tripped the Circuit Breakers of “in-service” equipment.

- Testing on BZ and CBF stopped and Operational Control returned.
- NGOC assisted with return of all circuits and equipment.
- Transpower Management advised

- Investigation commenced
- **PROTECTION WORKS STAND-DOWN 9-10TH March 2017** - allowing for:
 - Review of planning, work practices, procedures, Work Method Statements, competence and general mind-set of workforce
