Quality Alert

Event Number: Maximo 103076

Incorrect markings on compression sleeves

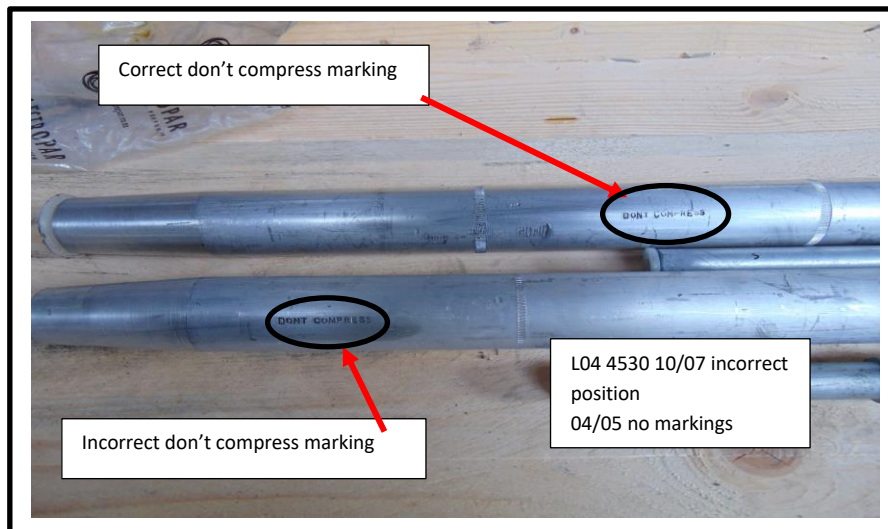
During pre-work inspection of emergency hardware, NL4 crew found some extended midspan joints had the marking "DON'T COMPRESS" in the wrong positions, or not marked at all.

There is a real risk that some of these may have been historically pressed and installed incorrectly and are now in service.

Contributing Factors: Manufacturer markings were incorrectly positioned.

Notified LMC Manager and then went through all extended mid span joints held in depot stores and found there were six with the wrong markings or no marking at all. These were quarantined.

Transpower SDM was notified and all other extended midspan joints for Goat conductor were checked and found ok.

Check all hardware prior to leaving depot.

Train Aerial Survey staff to recognise incorrectly pressed emergency extended mid-span joints.
