## Kopu Switching Incident

During switching for the Kopu disconnecter project there was a miscommunication between PowerCo, NGOC, and Northpower when relaying status of the equipment.

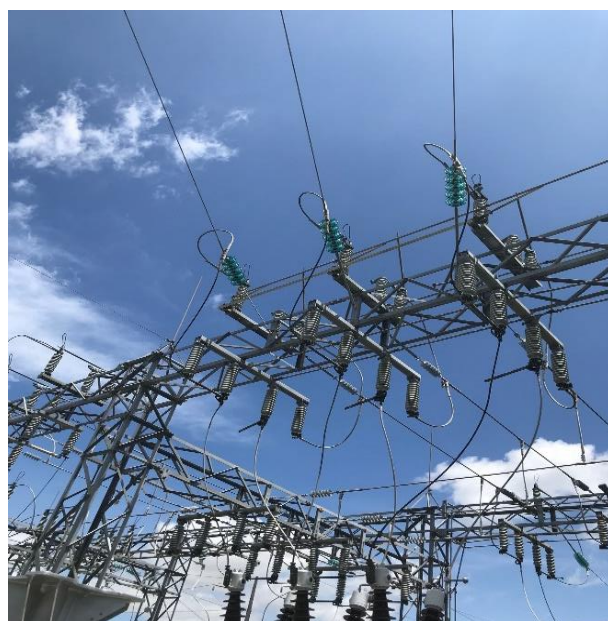
Industry procedures include a requirement for the maintenance switcher to prove the circuit is isolated using a Voltage Detection Device (VDD) before further action. Once tested, it was found that the feeder was not isolated and the maintenance switcher then contacted NGOC and advised that the equipment was energised, suspending work.

***This highlights the importance of accurate communications and following industry procedures when earthing equipment.***

- Switching stopped to confirm state of equipment
- NGOC confirmed state of equipment with Powerco and switching did not resume until PowerCo had confirmed the equipment was isolated

- Full ICAM investigation to be completed by independent party.
- Once ICAM complete, follow up alert to be circulated.
