# FIRST ALERT

Date: 6/3/2017

Maximo Reference: 96965

## 220kV Aluminium Bus Section Collapse

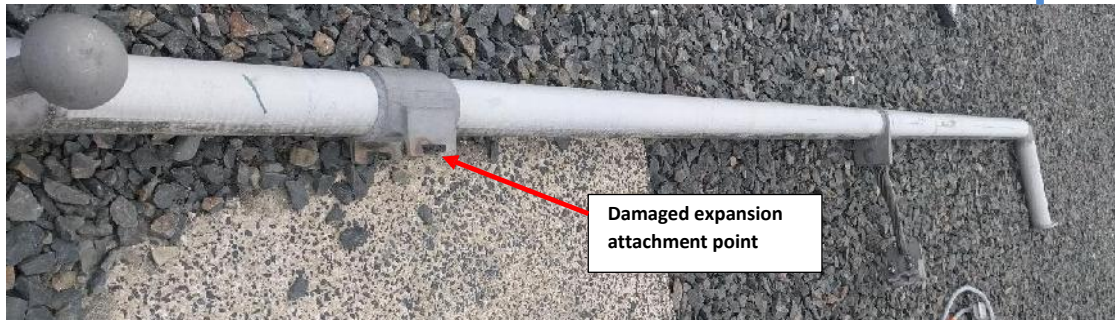
Figure 1 Aluminium section of bus

- After dismantling and removing a set of line traps during a CVT installation project, a section of bus broke off its support post (an expansion attachment) and fell to the ground.
- No one was working in the controlled work area at the time of the event.
- The support post expansion attachment to the bus was severely worn and may have contributed to the failure.

- Lift plan was in place for crane/hiab work and was being followed.
- JSA was current, on site and implemented.
- Good thorough Work Site Management Plan was conducted pre work.
- Consideration was not given to supporting the overhanging 220kV bus once the line trap was removed. This is a contributing factor for this event.

- Work was stopped and a “Take-5” completed. Work area checked for any other unseen hazards and the work method reviewed.
- Damage to the buswork reviewed and Electrix and Transpower Management advised.
- Investigation commenced.
- An additional follow up discussion was held at a “ToolBox” briefing with all site personal the next day.
