# SAFETY NOTICE

POWERCO

ISSUE No.05

## SAFETY NOTICE- No live line work to be undertaken on two piece 33kV sub-trans Insulators.

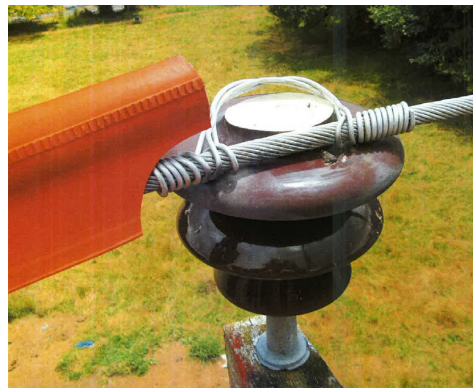
A high potential incident has occurred on the Powerco network where a 33kV insulator has failed during live line work. This incident involved an NZI 33kV two piece insulator whose top sheared off near to the point where the conductor is bound, while a Class 4 cover was being placed on the 33kV conductor.

In the interests of ensuring service providers are not exposed to undue safety risks there is an immediate halt placed on any live line work involving two piece 33kV sub-transmission insulators until further notice.

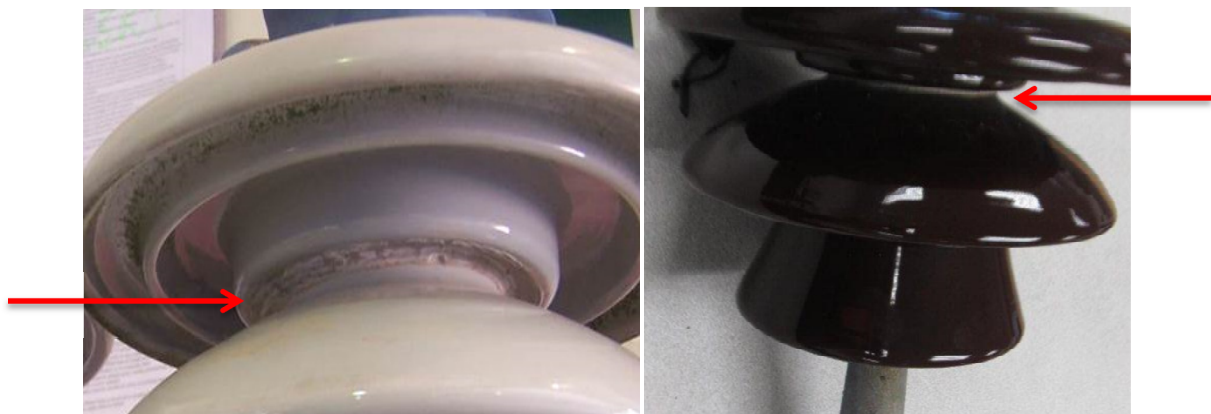
The two piece 33kV insulators can be identified by the cement bond that is visible on inspection. Below are some examples of this type of insulator. The arrows point to the cement.
