Zero Harm Alert

Emergency Water Repair Service Strike

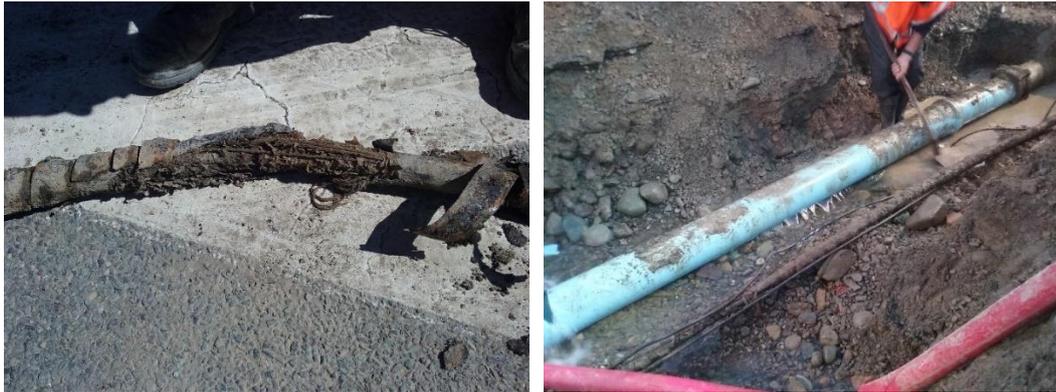
Photo Left: 11Kv damaged cable, Photo Right: Trench with proximity of Watermain to power cable

At 11:15pm Downer was notified of a major watermain burst on SH6 in Brightwater, the failed pipe was a 200mm "Blue Brute" uPVC watermain, feeding the local reservoir,

- The crew used two separate Cat4 and Genny Locators to survey the area, finding only telecom cables
- The crew commenced the excavation at 1:50am removing loose Asphalt from the trench using the cleaning bucket of the 8t excavator
- Two of the team noted the potential of underground power after seeing cables entering the ground 30m from the excavation, external locates were ordered although excavation continued.
- At 2:00am the crew noted the street lights go out soon followed by a flash in the trench, Crew immediately stopped works and awaited power authorities arrival

- Utility teams process for detection of underground services only identifies as a minimum the use of Cat and Genny to locate services prior to excavation,
- The cable was unable to be located due it being Lead encased (not uncommon in older cables)

- A stop work toolbox will be arranged and all Utility service crews reacting to emergency works will have findings in this report explained & expectations to prevent and reduce a similar occurrence outlined to them.
- Contact is being made with local power utilities for a change in process to provide 24hr external service locator support.
- A review and amendment to current SOP's and Reactive Works Process is underway to specific expected verification of underground services protocols.
