QUALITY ALERT!

11 – 33kV Cable Termination Quality Issues

Quality Alert REF No : 2018-006

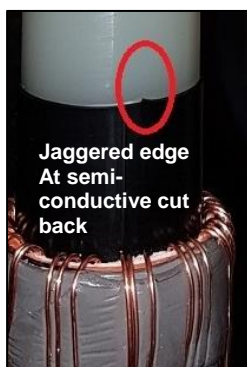
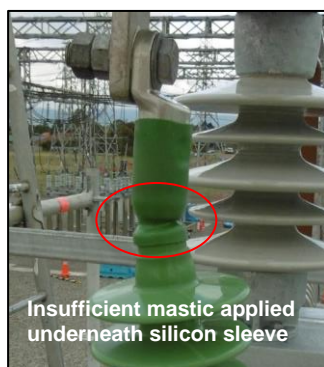
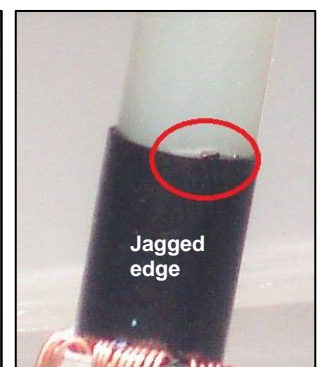
Submitted cable termination sheets and photographs have revealed several quality issues with installed terminations. The quality issues on these cable terminations based on the submitted photos included:

- Non-chamfered and jagged edge at the semi-conductive cut back.
- Copper screen wires not pressed into mastic which can allow moisture ingress over time.
- The top XLPE insulation was not beveled and rounded using correct tools. A knife was used leaving sharp edges.
- Inadequate application of sealing mastic between the cable lug and the XLPE.

1. The form attached in Appendix B of **TP.CL 01.02** is to be sent to tpcables@transpower.co.nz within **2 working days** of completing the work. TP.CL 01.02 is to be updated with this requirement.
2. There is work underway to improve the Training and Competency of those working on Transpower cables to improve the quality of this work, specify use of the correct tools and the QA process for completed work.
