# Alert

Health Safety Environment

13-03-2024

## What happened?

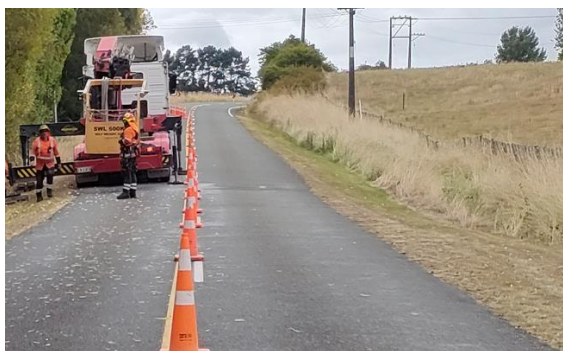
Figure 1. Downer contracted truck inside TMP

On Saturday 24 February, a Downer team was engaged in vegetation control for trees lining Colyton Road, Ashhurst. At 0900, while the team were setting up the Hiab in the conned off lane, a member of public driving a heavy truck drove through the worksite **approximately** twice the speed limit of 30km/hr, impacting the cones and the outrigger of the unloaded crane truck.

- The risk controls of the Traffic Management plan are compliant with NZ legislation, which were in place on the day.
- It is a requirement of the TMP to have a 1m Safety Zone in place. Where there are required adjustments to the TMP, we must ensure that all possible risk controls have been considered, and that the additional risk is controlled appropriately.
  - **Where the 1m safety zone is compromised it is now a Downer Requirement to stop traffic at both ends to eliminate the risk of uncontrolled drivers.**
  - **The additional risk is to be identified and mitigated by Downer crew and documented on the Crew Briefing plan.**
- Where roads are narrow and traffic are not obeying the traffic management requirements, consider if the job can be done a different way (e.g. from the paddock if possible), or stop traffic movement altogether while working near the live lane.

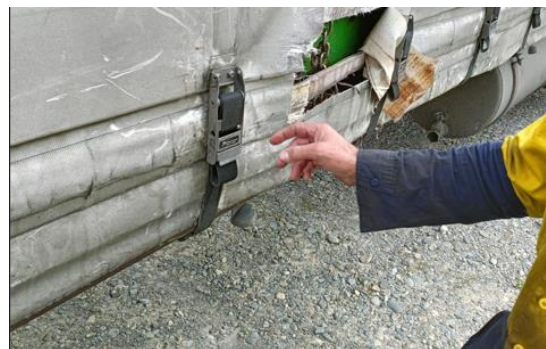
Figure 2. Public truck
