# SAFETY ALERT!

## Hydrogen Sulphide (H<sub>2</sub>S) in Water Deluge Pipework

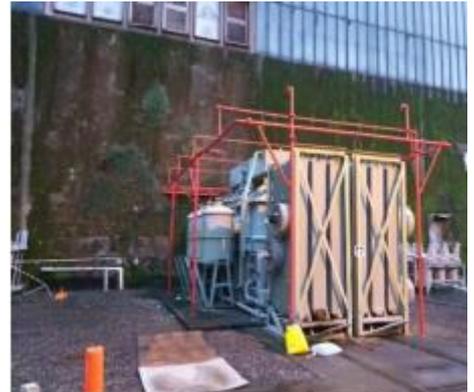
Whilst using an angle grinder with a cutting wheel to cut through steel water deluge piping, a small flame was observed originating from inside the steel pipe.

The sparks produced by cutting the steel pipe with the grinder ignited a gas that was present inside the redundant pipe work.

- The pipe work that was cut had been out of service for over 10 years and was still connected to the deluge system located inside the redundant power station turbine hall.
- This system held stagnant water containing moss and algae. It is suspected that the decomposition of these organics caused the production of H<sub>2</sub>S, which became trapped within the pipework.

- H<sub>2</sub>S can occur when organic material in stagnant water decomposes in the absence of oxygen.
- H<sub>2</sub>S generated from biodegradation is a risk, not only in services but in low lying areas.
- All redundant services (pipes etc.) must be tested for presence of gas prior to hot work taking place.
