## Asbestos in the Penrose Old Control Building

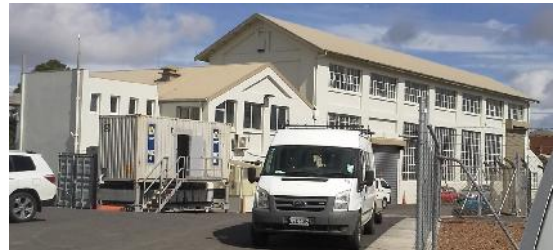
During site investigations for a seismic upgrading project of the Penrose Substation Old Control Building, loose and broken fibrolite type sheeting containing asbestos was identified lying in the ceiling space of the control room.

It is understood that the asbestos containing material located in the ceiling space had been there for approximately 20-40 years. It appears the broken pieces were left behind when the original roof was replaced. Due to ceiling vents in the control room and a roof vent into the ceiling space, some asbestos fibres have entered the control room area during certain weather conditions.

- Access to the Old Control Building was restricted and signage installed. Entry required authorisation, PPE training and compliant asbestos PPE.
- Samples were gathered by a registered asbestos company and sent to a certified laboratory for testing. Results confirmed that the material located in the ceiling space contained Chrysotile asbestos. The site was further tested to determine the extent of contamination.
- An investigation was initiated to identify root causes.
- An asbestos expert was also engaged to support staff and management (including staff of Service Provider companies) to understand hazard/risk levels and potential exposure. She also met with affected staff to discuss concerns and provide a factual report for staff.
