## Electroswitch Damage Found During Precommissioning Testing

Quality Alert REF No: 2019-003

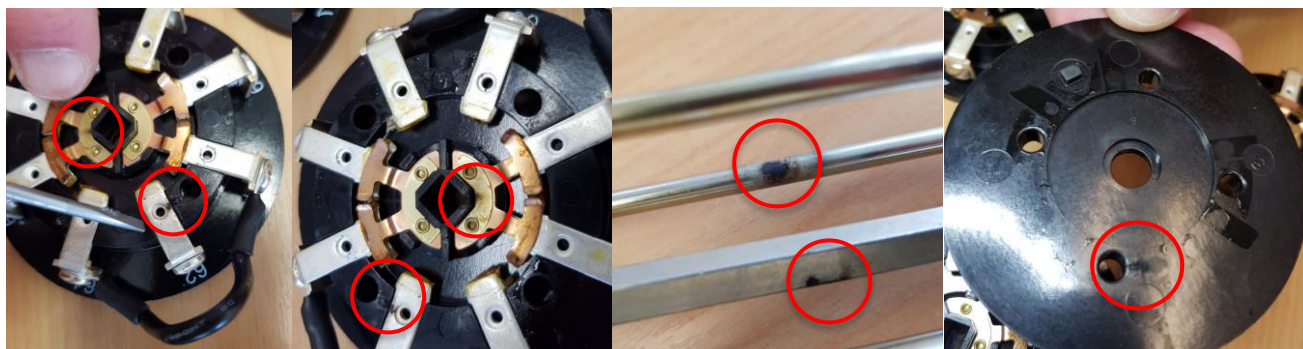
During recent acceptance and pre-commissioning tests at Kinleith Substation, a low insulation resistance (IR) reading was returned on an NCT secondary circuit. Subsequent investigation found that the IR fault was inside the protection test switch (Electroswitch) requiring switch replacement before commissioning could proceed.

An internal examination of the switch found that sustained arcing had occurred between the Electroswitch moving contact and earthed shaft, and between an Electroswitch fixed contact and earthed through-bolt.

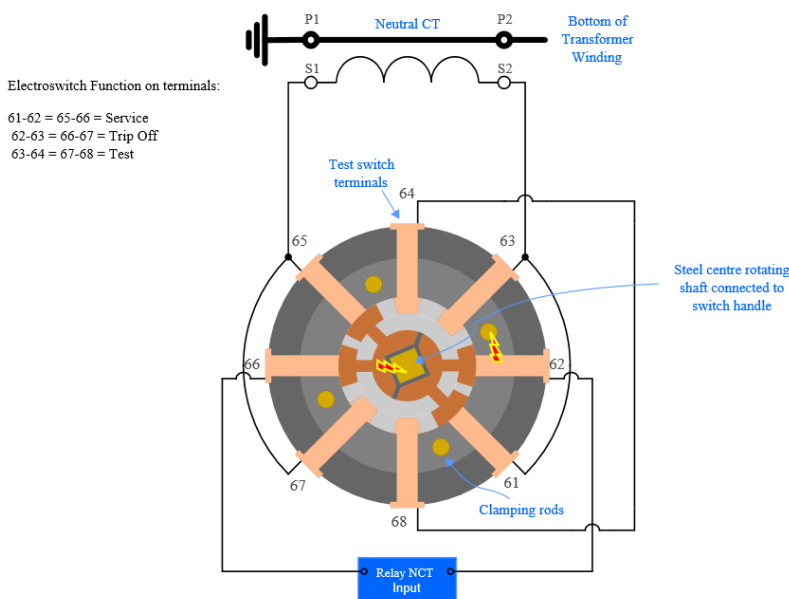
There are several ways that a high voltage can appear across an Electroswitch CT wafer. One is primary current flowing in the CT with the switch in “Test” position and the TP installed shorting link missing.

Another possibility is primary current flowing through the CT with the switch in “Service” or “Trip Isolate” positions and the relay missing or its CT input disconnected.

Examination of the circuit showed that the arcing occurred between the contacts connected to the relay NCT current input. The relay NCT input must therefore have been open circuited with the switch in “Service” position while primary NCT current was flowing.

1. When undertaking acceptance and pre-commissioning testing it is essential to confirm the integrity of all CT secondary circuits prior to injecting primary current, e.g.:

- Are protection relays installed and have the associated CT secondary circuits been connected ?
  - Have test switches been acceptance tested and are all required links installed ?

- Has end-to-end continuity of the CT secondary circuit been proven ?
  - Where appropriate, have shorting links been applied to ensure that CT secondary circuits are not open-circuited ?
