FIRST ALERT

190Ah capacity battery has shorted out on the panel

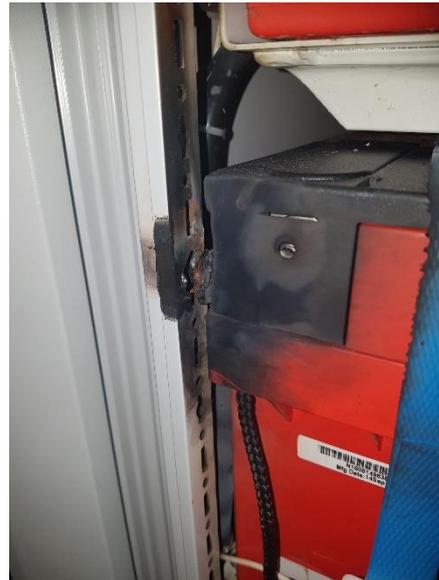
On 23/4/2018 at Maungatapere it was discovered one of the extra capacity 190Ah batteries installed for the TransGO project in Northland earlier last year has shorted against the panel chassis.

As this occurred before the MCB protection was installed, the arcing continued until there was no more panel material left between the battery negative terminal lug and the panel.

- The battery string has been isolated.
- An investigation has been arranged to determine the root cause of the incident.

There will be a request to Service Providers with 190Ah batteries located in substations in their area, to check the clearances between batteries and the chassis of the panels.
