QUALITY! ALERT!

Non-compliant Concrete Over Grillage Encasements

Quality Alert REF No: 2019-004

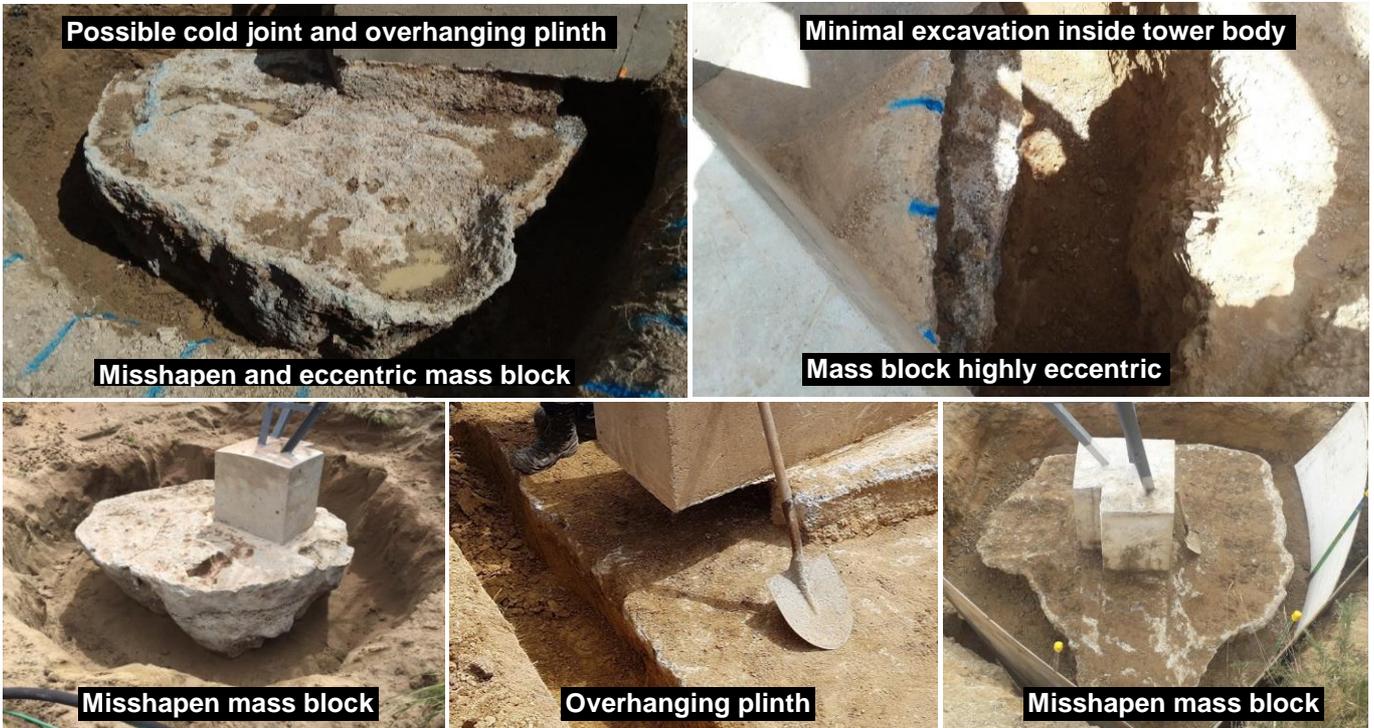
Several concrete over grillage encasements that are non-compliant with the design drawings have been uncovered as part of additional strengthening works. The non-compliant encasements have misshapen and eccentric (offset from the leg) mass blocks. Encasements have also been found with gaps between the plinths and mass blocks, and the concrete compromised by being contaminated with site material. The uncovered foundations are expected to have reduced structural capacity because of these issues.

It is suspected that combinations of weather, high water table, insufficient or incompatible formwork, poor workmanship, and inadequate oversight contributed to the identified issues.

This is a reminder to the industry to be vigilant in ensuring quality products are installed, key hold points are enforced, and QA records are completed and retained. An investigation is underway to determine the extent of the issues and identify whether a review of historic QA information and further exhumations may be required.

- Follow design drawings, specifications and procedures, ensuring QA plans are in place and QA records are appropriately maintained.
- Raise issues as soon as known and create a Maximo EQUIPMENT \ WORKMANSHIP incident or near miss.
