## WORKING ON CURRENT TRANSFORMERS IN THE EARTH PATH

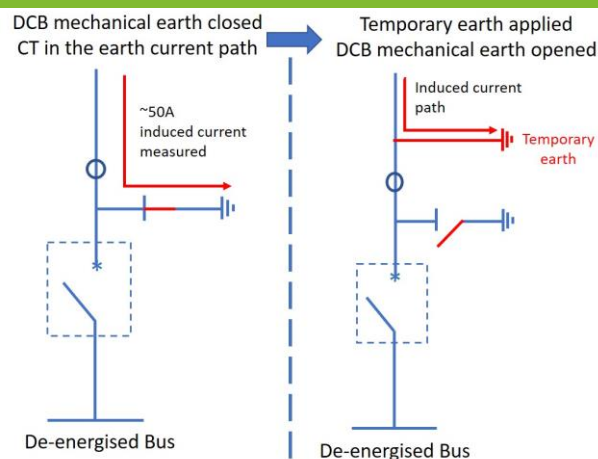
During a current transformer (CT) ratio change at Wilton substation in late 2016, crackling sounds were heard as the secondary wiring was being disconnected. The service provider stopped work and further investigated. It was found that 50 A of induced current from the transmission line was measured at the main earth of the DCB earthswitch.

Because the DCB earthswitch is behind the CT, the induced current in the earthed transmission line passes through the CT before reaching the earthswitch. This induced current will cause dangerous voltages on the CT secondary wiring.

The service provider reassessed the temporary earth requirements and has applied the temporary earths on the line side of the CT. Then opened the DCB earthswitch to remove the CT from the earth path, while the CT ratio change is taken place.

Note: The temporary earth requirements must be assessed on a case by case basis

- When working on secondary circuits of a CT and there is no line side disconnector to isolate the primary circuit, the CT will need to be removed from the earth path. This can be achieved by applying a temporary earth on the line side and remove the mechanical earth at the bus side, prior to the work on the CT.

- Alternatively, the HV line side droppers can be removed while ensuring the line termination and equipment to be worked on remain earthed.
- If the CT cannot be removed from the possibility of induced current and returning fault current, the CT secondary wiring may be shorted across the full secondary winding, if it is safe to do so. Note: when shorting the full secondary winding, if existing wiring is disturbed (disconnected) then additional testing will be required prior to returning the CT to service. Reassurance is also required for removing any applied shorting arrangements prior to completion of work.
