SAFETY! ALERT!

Maximo REF No. 97682
Event Date: 06/04/2017
Issue Date: 14/07/2017

New Plymouth Substation MAD encroachment/Bus Zone tripping - issue 2

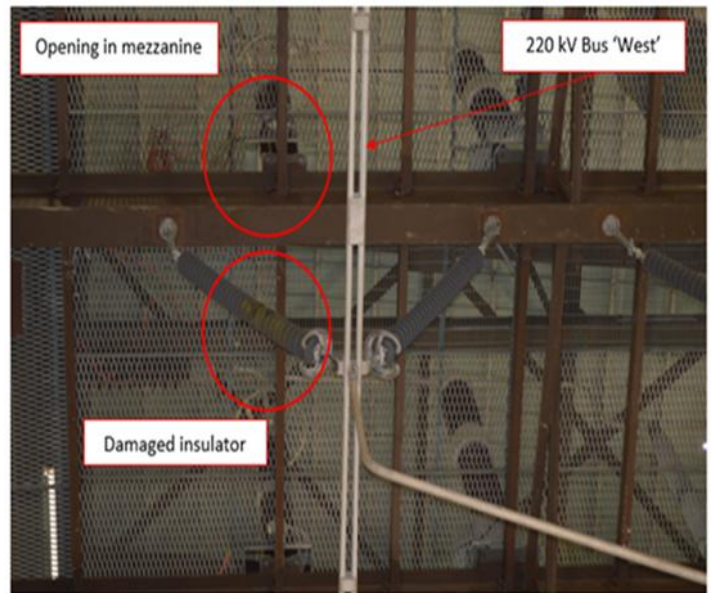
During diagnostic inspection and servicing on the 220kV structure and associated equipment at the indoor New Plymouth Substation, the 220 kV MAD was encroached by a 240V extension lead.

This occurred when a member of the Electrix maintenance team was lowering the lead through an opening in the mezzanine floor above Bay 260, which is directly in line with the live, in-service 220kV busbar immediately below the mezzanine. When the lead encroached the minimum approach distance, a flashover and a 220kV bus zone tripping occurred.

Incredibly, the team member lowering the lead was uninjured despite the extension lead being severely damaged beyond repair. No damage was sustained to PPE (boots, overalls etc), however the immediate bus support insulator for the Bus West was damaged as a result of the 220KV earth fault arc flash.

- Permanent ban of all work on the NPL mezzanine floor area above live in-service equipment.
- Reinforcement of Working Above Live Equipment Process (WALE) and ensure TP542 documentation is signed and agreed by both Transpower and Service Provider as part of the job planning process.
