safety alert

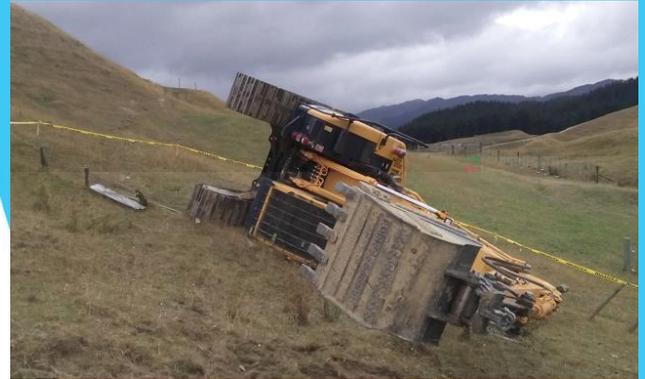
Excavator carrying compacted/crushed tower steel was travelling to the fence line to place the tower on the other side of the fence for the metal recyclers to collect.

The excavator was moving across the slope/incline with its tracks facing towards the fence line approximately 45 ° uphill.

When the compacted tower was slewed by the excavator boom from its uphill position to downhill, the excavator rolled 90 degrees onto its left side.

Note: Photograph taken post event

Processes must be followed and when changes occur, a hold point brief/management of change and risk management processes should be undertaken and communicated to ensure activities remain within the scope of approved procedures and work processes, are safe and meet the requirements of both Electrix and Transpower in relation to a safe working environment.
