# Safety Alert

## 33 kV CB internal fault

**Event Number:** V2403

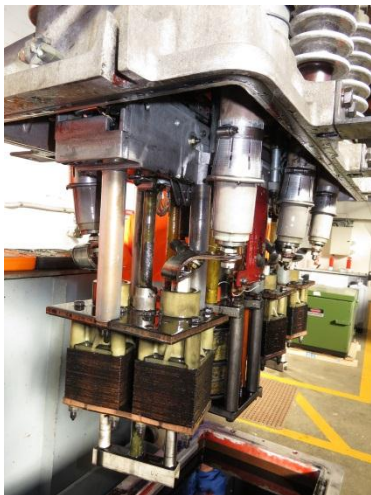
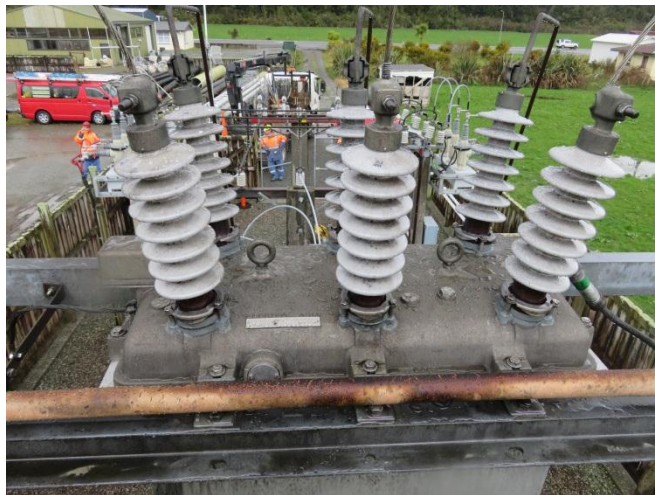
An internal fault occurred on a 33kV Cooper Type WVE38X Circuit Breaker (CB). As part of the zone substation shutdown, to carry out routine 5 yearly preventative maintenance, the 33kV CB was refurbished. During remote test operation prior to restoration an internal fault resulted in approximately 6 or 7 litres of oil being sprayed throughout the switchyard.

Both internal HV closing coil fuses were found to be blown on initial inspection. The closing coil tested okay, with no obvious cause evident for the CB failure. An investigation is in progress to determine the root cause.

Equipment was isolated. An incident investigation was initiated.
