# FIRST ALERT

## Drill Rig Pins Contractor resulting in Fractures

**Location:** ROX-TWZ A Line Roxburgh Foundation Strengthening Project**Incident:** Unloading of Drill Rig from Transporter

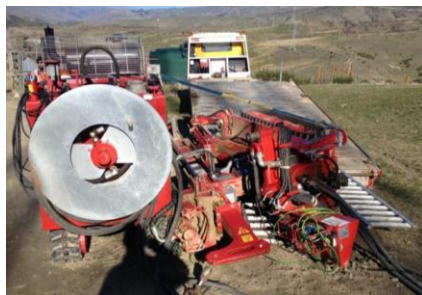
The drill rig is made up of two parts, a drilling rig and a power pack. The first part of the rig (power pack) was unloaded down the ramps from the transporter truck and parked next to the transporter. The second part (drilling rig) was being unloaded down the ramps, but was seen to slip on the tracks and become skewed. Movement was stopped, and the drill operator (who was controlling the rig remotely)

investigated to see how best to proceed. The decision was made to reverse the rig to attempt to straighten it. As this was happening, the rig slipped further, and tipped on the transporter, pinning the drill operator between the power pack section of the rig (already parked next to the transporter), and the toppled drill rig. The operator managed to get free of the fallen machinery, but sustained multiple broken bones.

- Ambulance called to site and medical attention for injured party (subsequently airlifted to Dunedin Hospital)
- All onsite work halted and evidence gathered
- All persons on site underwent drug tests (negative results)
- Worksafe NZ attended site with Contractor management at 5pm
- Investigations commenced by ElectroNet and Contractor company
