## Bobcat Backs into 220kV Bus Post

### Overview of event

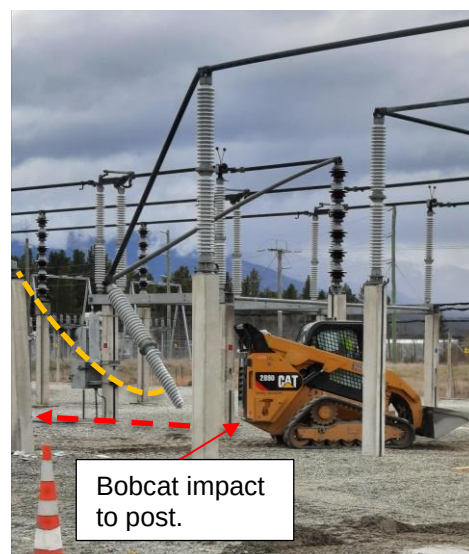
- During yard work, a Bobcat backed into a 220kV bus support post.
- The impact to the post caused the bottom insulator to break and allow the bus to sag.
- There was no injury or loss of supply.

- Bobcat weighing 7T backing without full communication with the safety observer (SO). An airhorn was in use, however, due to the enclosed cab of the Bobcat the communication was limited.
- A Bobcat, as with any mobile plant, has some limited vision when backing. Coupled with inadequate communication and poor positioning of the SO, the Bobcat's deviation was not observed in time to stop the event.
- The Bobcat driver moved to the final task for the day without communicating his movement with the SO.

- All work ceased, bobcat was ordered to stop and the driver to remain in the cab.
- A forced outage was scheduled.
- The bottom insulator was replaced and the copper 220kV bus reinstated.

- All movements of mobile plant in high risk situations, such as working under or around in-service equipment must be undertaken with effective "TWO-WAY" communication established.
- Additional measures such as Marked access ways, Protective barriers, Demarcated pathways should be considered in the planning stage of the project.
