Transformer oil leaked during transportation, resulting in an Environmental incident (LL257)

Incident	Description	
Event Date: 22 April 2024	Time: 12:35 pm	Location: 218 Heta Road, New Plymouth
NP Reference / External Reference: Northpower INV14829 / Powerco Risk Manager ID: 1384031

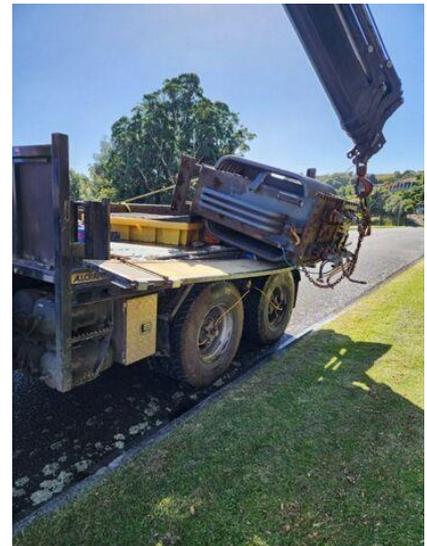
On 22 April 2024, a New Plymouth crew was transporting a transformer (approx. weighing 500kg) back to Powerco, when it fell sideways on the back of the truck whilst going around a corner.

During the impact, the transformer damaged both sides of the railings on the side of the truck, i.e. point of contact, and the section it was tied down to.

It is to be noted that the top of the transformer was heavily rusted, which is where it started to leak oil as soon as it toppled over.

Oil could be found on the road and adjacent grass verge. The Northpower crew placed a hydrocarbon sock near the stormwater drain to minimise the risk of oil seeping into the drain.

- **Safety Notice 2023 – 18: Transportation of Refurbished Transformers** outlines Powerco requirements to be followed. For this incident, all the steps were followed, apart from wrapping the transformers in plastic. This resulted in the oil leaking from the transformer when it toppled over.
- The crew failed to follow correct tie-down methods when they secured the Transformer to the truck:
 - One strap was used to secure the transformer instead of two.
 - The strap was secured to the side rail, instead of the designated tie-down point on the deck.

Transformer containment bags are to be purchased and distributed, but until this has been done, all the requirements as per Safety Notice 2023-18 are to be followed.
