# FIRST ALERT

Maximo Incident 7835

## Wanganui 33kV Feeder Cable Strike

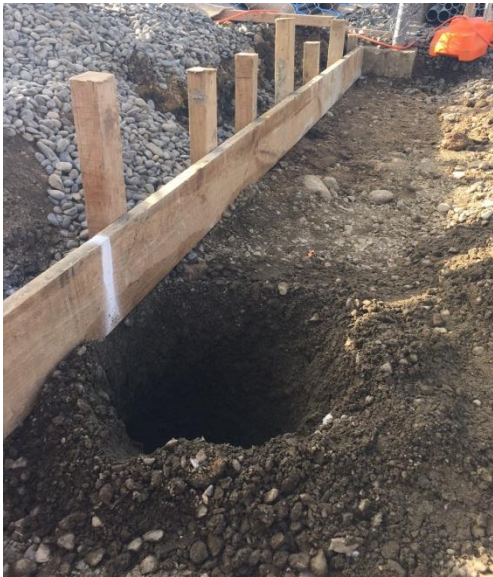
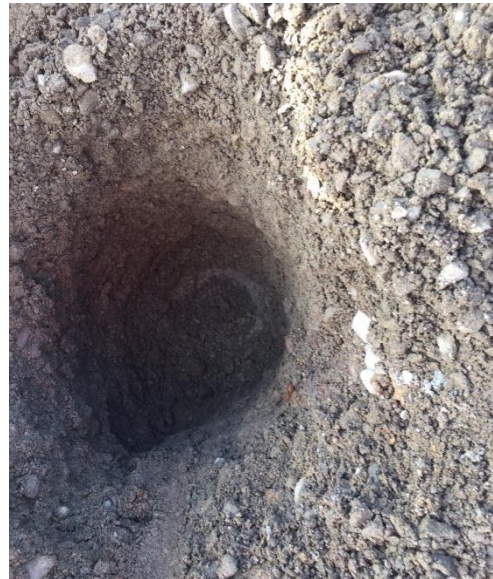
At 2.02pm on the 19<sup>th</sup> May 2015, during the excavation of a new security fence at Wanganui Substation, an excavator with an auger struck the WGN CB 2032 feeder cables while being used for drilling post holes. The ground radar had earlier indicated that there was something in the ground at 600mm in depth, and this was assumed to be mag-slab, as it was discovered during excavation of cables nearby to the location. Due to this, the maximum auger depth used was 600mm resulting in the auger nicking the sheath of the 33kV XLPE power cable of WGN\_CB\_2032 Taupo Quay feeder and resulting in a tripping of WGN 33BS A.

- Work immediately stopped and supervisor ensured staff safety
- Damage to the plant assessed
- Investigation was carried out to identify the tripped cable, and technicians were on site to assist with diagnosis and restoration. Subsequently, an investigation was conducted to identify the root cause of the issue.
