FIRST ALERT

Otahuhu 220kV Cable Sealing End Failure

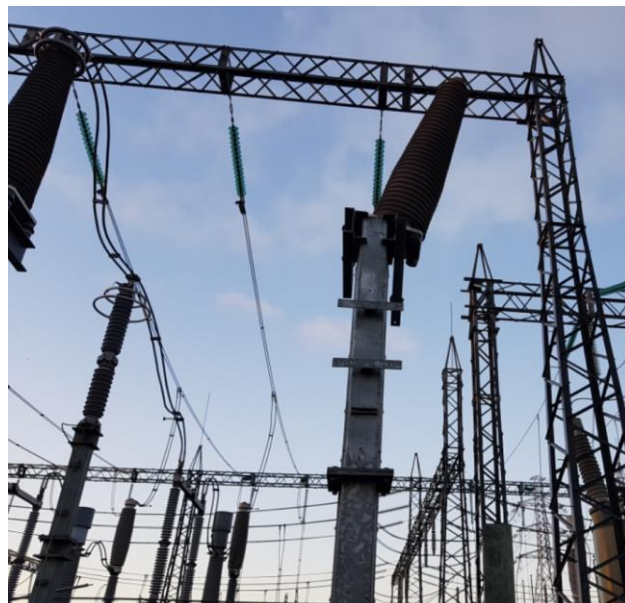
On inspection, one of the 220kV Cable Terminations in the Otahuhu 220kV Switchyard was found to have catastrophically failed.

Fortunately, no adjacent equipment was damaged and there was no-one in the vicinity at the time of failure. The voltage and frequency disturbance did cause some network disturbance but there was no loss of connection.

- Label the Temporary Hazard board at OTA substation: "KEEP CLEAR OF 220kV OUTDOOR CABLE SEALING ENDS"
- Organize outages in order to internally inspect these cable terminations, based on risk priority.
- The above circuits must not be re-livened in the event of a tripping without visual inspection of the Cable Sealing Ends and the Regional Service Manager approval.
