## Otahuhu 220kV Cable Sealing End Failure

### WHAT HAPPENED?

Transpower issued a first alert in June 2018 in regards to the 220kV cable sealing end failure on the Otahuhu Tie Line 5 circuit.

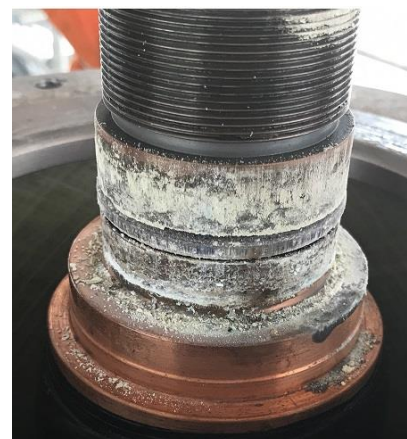
Since then, a full investigation of the failure and the subsequent urgent repairs have been completed. Based on the evidence and findings of the investigation, the 220kV cable sealing end failure was caused by moisture ingress. All in-service 220kV cable sealing ends at Otahuhu have now been internally inspected and the oil tested. During the inspection process, two additional cable sealing ends were found with severe moisture ingress. Nine additional cable sealing ends were also found to have significant defects.

Based on the investigation, the cause of the failure is due to moisture ingress. The root cause of the moisture ingress is likely to be a combination of the design and installation workmanship which could accelerate the failure of the moisture seal. This allows moisture ingress into the cable sealing end and lead to the ultimate failure.

All of these cable sealing ends have been repaired and refurbished. New preventive maintenance procedures are being applied and scheduled.
