Western Power Distribution Versalift VOE36 MHI Self-levelling system inspection

Service action

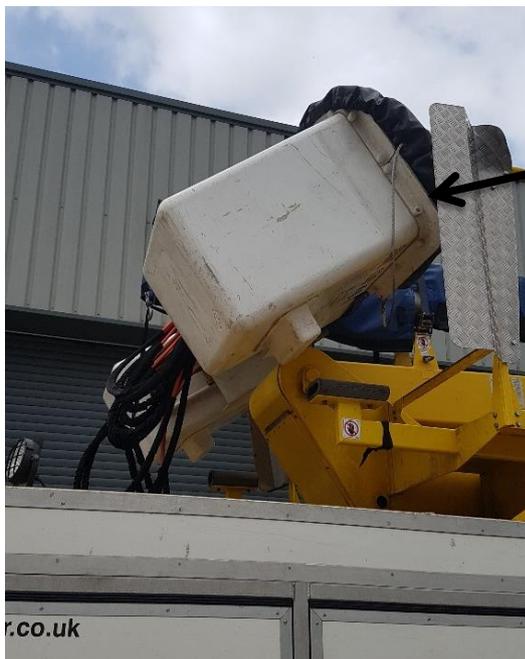
A thorough investigation at Versalift with an independent engineer present identified the cause for failure being a spiral roll pin that locates a pivot pin within the levelling system that had sheared, allowing the pivot pin to come out and the uncontrolled movement of the buckets.

Movement of bucket from
its normal vertical position

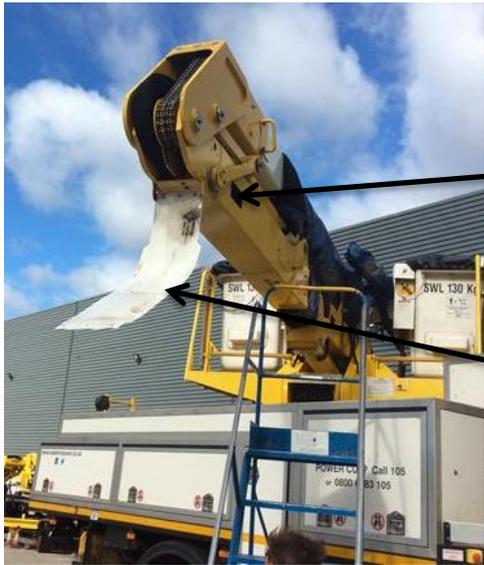
Location of near side inspection plate
 (Photo shows plate removed)

Front knuckle cover top securing bolts removed to allow access.

Using access ladders remove the front knuckle protection cover and the near side boom inspection plate.

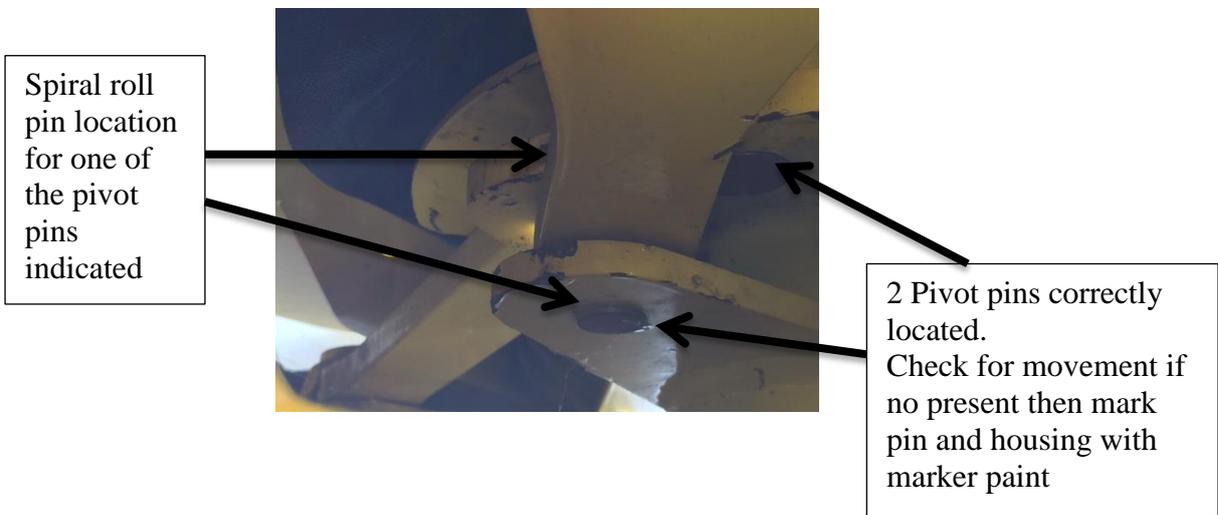
Spiral roll pin location for one of the pivot pins indicated

2 Pivot pins correctly located. Check for movement if no present then mark pin and housing with marker paint

We have been advised that the spiral roll pins should be tight and flush to their housing when correctly fitted.

After the above inspection, dab the interface between the pivot pin and its housing with marker paint.

If a spiral roll pin is found to be proud of its housing or has movement, the vehicle must be removed from service and inspected by our maintenance supplier. Report your findings immediately to your Transport Area Controller.
