Date Issued: 02 June 2017

Incident Title: Aichi EWP – failure of weld in boom support

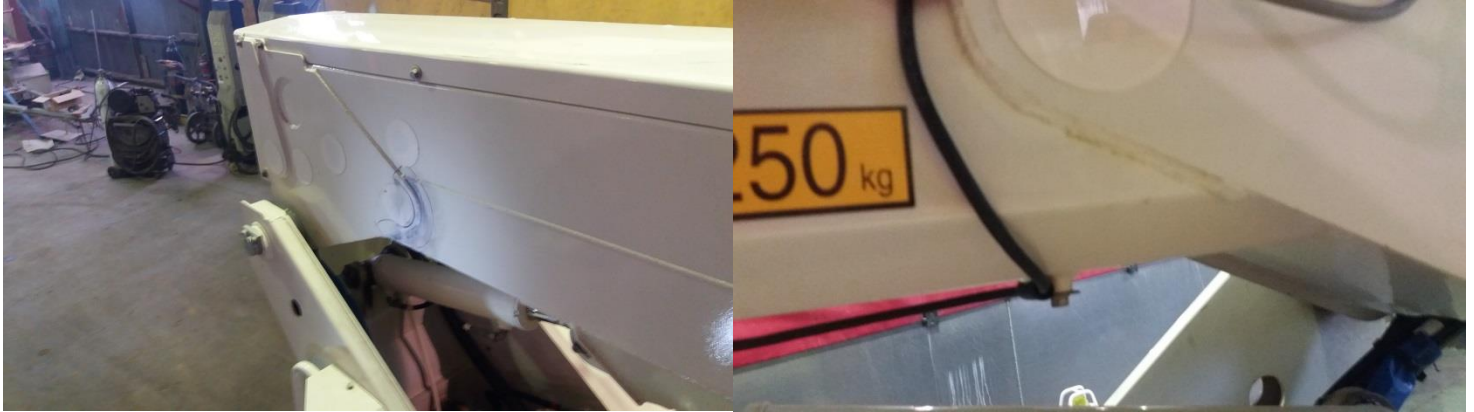
Event Details: During periodic boom inspection and certification, the inspector identified a failure in a weld in the lower portion of the boom, with a crack like indication detected at the weld toe extending for approximately 220mm. Further inquiries are being carried out to determine the cause of the failure. The EWP, which is two years old, has been removed from service until repairs and/or replacement of the failed section has been initiated.

- EWP operators – please ensure a thorough pre-start inspection, paying particular attention to welds is completed on all EWPs, especially Aichi models. Any signs of rust or cracks in the vicinity of welds will require further action.
- Any irregularities identified during these inspections must be reported to your supervisor immediately and the EWP must be tagged Do Not Operate.
