# **Update: Trailer Axle Break**

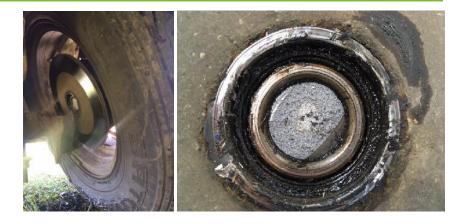
During the journey an axle stub has sheared off. The wheel detached from the trailer but jammed under the mud guard causing the trailer to skid along the grass track on the tire for a short distance.

However, while the axle was loose the chattering of the axle has caused fatigue in the stub axle (half-moons can be seen in the photo above). This has led to the eventual failure of the stub axle.

- The trailer suspension has been replaced with Duratorque axles, providing better independent suspension and eliminating the use of U bolts.
- Check U bolt tightness during trailer inspections.
