Date Issued: 09 July 2018

Incident Number: 873463

Incident Title: ICAM 54
Live cable strike Pak'nSave

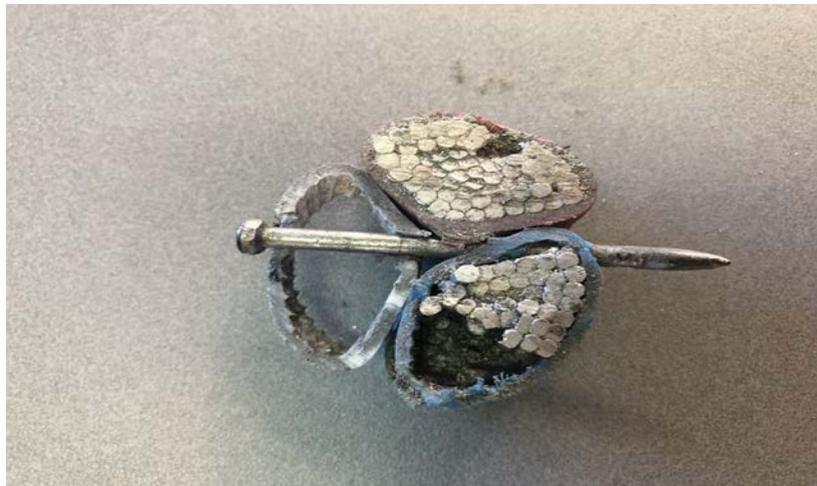
On 13 March at 1530 hours a pillar box was to be installed and connected into a spare de-energised 400V link cable. This was part of a job to supply power to a new car charger at Pak'nSave Frankton. Three of the cables feeding out of the transformer were exposed and one was identified as the de-energised cable. The cable was spiked and cut through on one side (at this stage there was no indication the cable was live). The field workers started to cut the other side of the cable when there was a flash. Immediately after this occurred all work stopped and system control were notified. The investigation identified that several critical controls during the cable identification steps were not adequate to safely identify the correct de-energised cable.

- Develop a standardised procedure for cable identification.
- A fit for purpose cable spiking tool is to be purchased for the Frankton depot.
- A standardised and fit for purpose cable identification device is to be purchased for all depots that frequently identify underground cables.
- Provide training on electrical theory relating to neutral identification and testing methods.
- Provide training on cable locating principles and procedures.
