Safety notice

Issue 6 | Rev 1 | June 2024

OPERATION OF SAFELINK SERIES 1 RINGMAIN UNITS (RMU's)

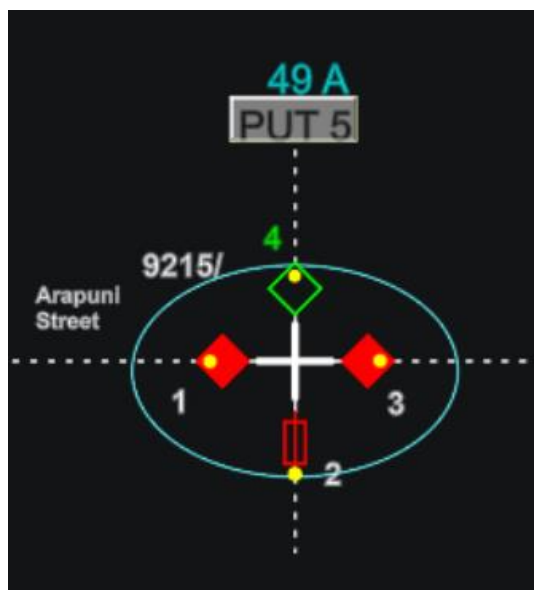
- All known switchgear of this type is marked on SCADA and are denoted by a blue oval around the switch as seen below.

Figure 1. SCADA symbol for suspected Safelink Series 1 switchgear

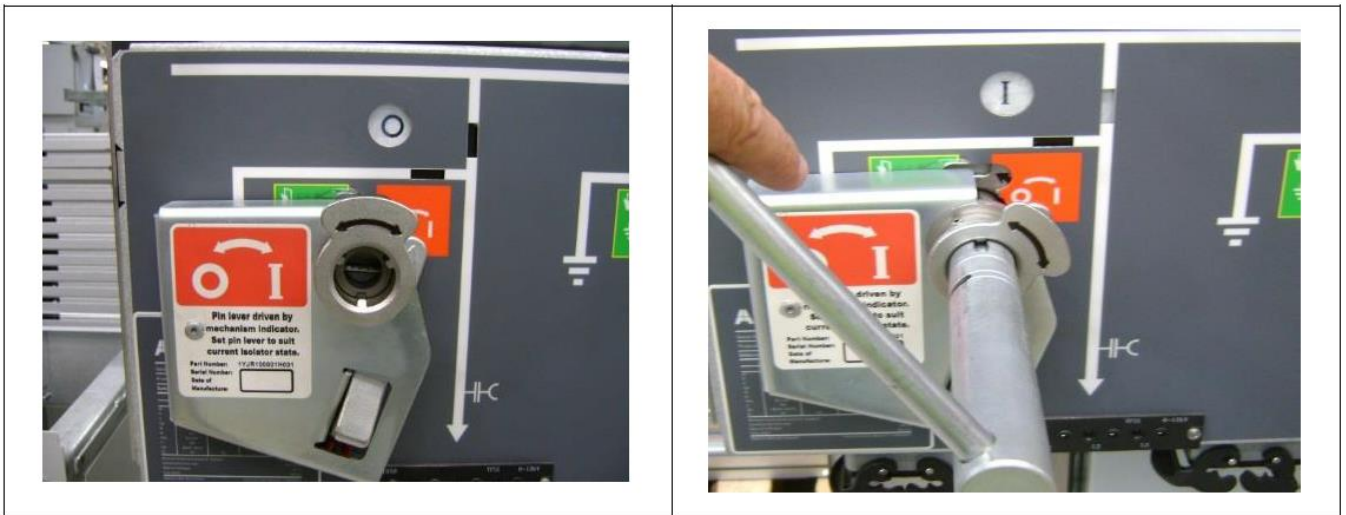
- The manufacturer has developed an over travel arrestor (OTA) handle which fits over the handle. The OTA safely stops the moving contacts by arresting and stabilizing the switching mechanism.

Figure 2. Over Travel Arrestor Handle fitted between switch and handle

- A first generation of OTA handles have previously been issued to Powerco approved contractors.
- Modifications are being finalized to ensure correct operation of the handle with Powerco's dual locking system. The second-generation OTA handles will be issued as soon as it is approved for use.

- These units must only be switched from ON to OFF with the OTA handle, unless:
 - The unit is de-energized, or
 - if the action is to de-energize the circuit, ensuring that in the event of overtravel, the live circuit will not come into contact with earth.
