Event Date: 19/08/19

Classification: Damage

First Alert

33kV Cable Sheath Damage

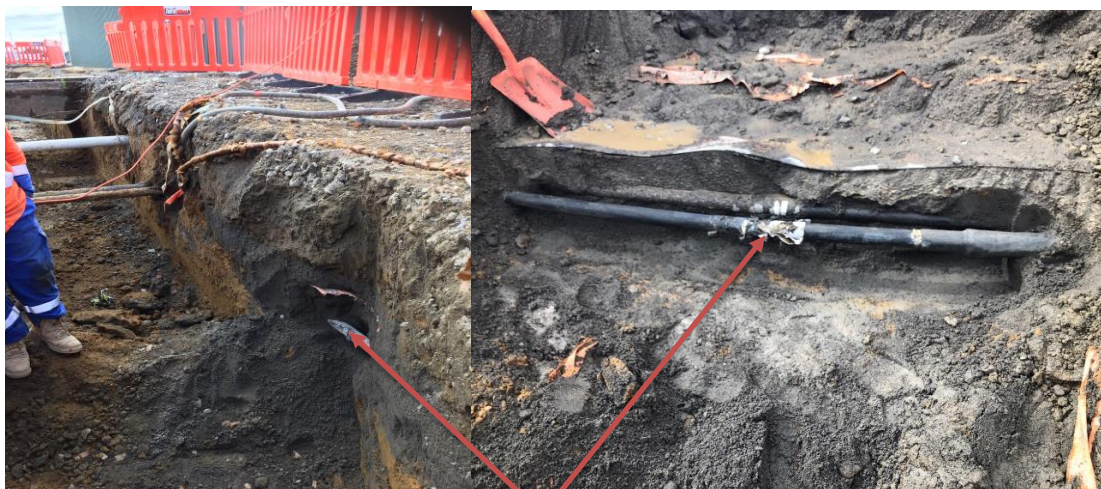
Damage location

Whilst excavating a new HV cable trench the excavator bucket contacted an in-service single core 33kV cable. A Permit To Dig (PTD) process was in place with the in-service cables shown on the Issued for Construction (IFC) drawing. The cables were also shown on the Reveal Ground Penetrating Radar (GPR) report. Safety Observer and Stand Over personnel were observing the excavation works.

Work was stopped immediately and damage to cable sheath reported.

- Project Manager must:
 - ensure all job packs hold latest versions of documents and all relevant information prior to any digging works;
 - ensure PTD Stand Over has reviewed all available drawings, scans and reports prior to excavation; and,
 - locate any known services by hand digging or hydrovac techniques within 500mm of known service locations,
 - Ensure stand over informs supervisor and excavator operator when a significant change in ground materials or strata is observed, and reviews the implications
