FIRST ALERT

Marton Outdoor Junction Box Transformer Trip

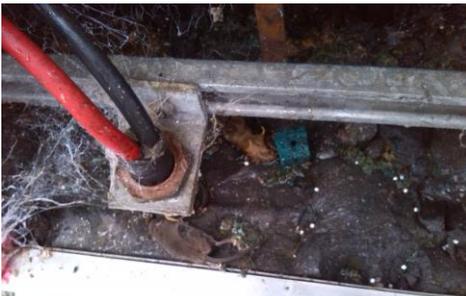
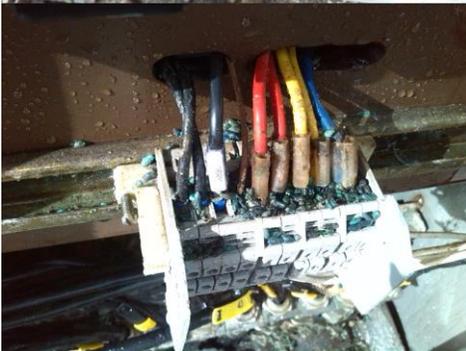
The cause of the trip was due to a combination of rat droppings and moisture ingress into the ODJB.

Maintenance staff were on site completing a DC battery sizing exercise. This required staff to access the ODJB to complete voltage and current measurements. The Technician opened the ODJB, applied some test equipment and found significant rat droppings on the termination blocks, and two dead rats at the base of the ODJB.

The combination of moisture and rat droppings resulted in leakage voltage appearing on the transformer protection terminals, initiating a Buchholz trip.

- Remaining work was immediately stopped.
- A tarp was set up, and cleaning of the terminal blocks and removal of rats completed.
- A heat gun was used to completely dry the ODJB.
- Wiring checked, all alarms cleared and MTN T2 restored at 1517.
- Closer inspection of vermin proofing & water tightness to be completed on all ODJB's in region during next station inspection.
