# FIRST ALERT

Date of Incident: 30/05/2016

Maximo Reference: 91677

## Blasting Strike

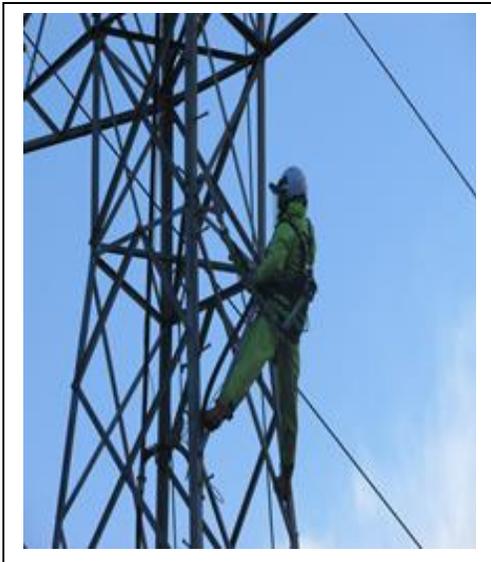
A tower painting employee was wet abrasive blasting using the air assisted (TORBO) method at 110psi. He was positioned in the body of the tower approximately halfway between the waist and third diaphragm on A.B face. The employee activated the blast unit by inserting the magnetic safety breakaway and depressing the switch. On coming up to pressure the hose flexed and he lost his grip. The hose dropped, falling backwards past him. The magnetic safety breakaway activated as designed but not before the blast stream (garnet, water and air) contacted the left cheek of his face behind his visor and in front of his balaclava. The employee immediately communicated to the site supervisor and climbed down off the tower.

- The employee immediately stopped work and communicated to the Site Supervisor that he had an incident and was able to descend unaided from the tower.
- The Supervisor shut down the site and the team administered first aid.
- Management travelled to site and transported the injured employee to hospital for assessment. The rest of the team were stood down for the balance of the day. The hospital cleaned the graze and cleared the employee to resume full duties.
- A detailed investigation (short form ICAM) is underway
