Protection Barrier Measures and Controls

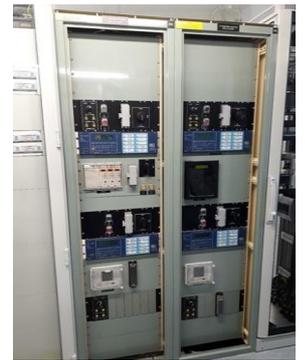
A protection technician inadvertently sent an InterTrip Send command from the wrong relay, to the remote end's incorrect relay (from SVL T2 Protection to ALB CCT 2 Line Protection).

There were two consecutive outages planned on CCT 1 and CCT 2, on the same day. The technician had connected his laptop to the wrong relay, prior to the commencement of the first outage.

Technician did not check/identify the correct protection relay prior to issuing the command. The Work Method Statement (WMS) being used did not prompt them to apply the required blanking/barriers.

- Follow the [TP.SS 06.56 Work authority procedure](#) for demarcation. (Outlined in Page 18, Section 4 Principle Requirements and Page 36, Section 9.3.2 Demarcation of Work Areas)
- All service providers ensure technicians apply the correct controls (blanking of "in service" cabinet(s))
- All service providers ensure their technicians have blanking panels readily available.
- All service providers review their Work Method Statement (WMS) documents, to ensure the key step (apply barriers) is included on the template for every job.
