# Lessons Learnt – LL149

## HEN-MDN A - Earthwire Drop

| Incident | | Description | |
|---|---|---|---|
| <b>Event Date:</b><br>01/05/2019 | <b>Time:</b><br>09:20 | <b>Location:</b><br>HEN-MDN A, Span 167-166 | <b>NP Ref.:</b> INV3448<br><b>External Ref.:</b> Maximo #120651 |

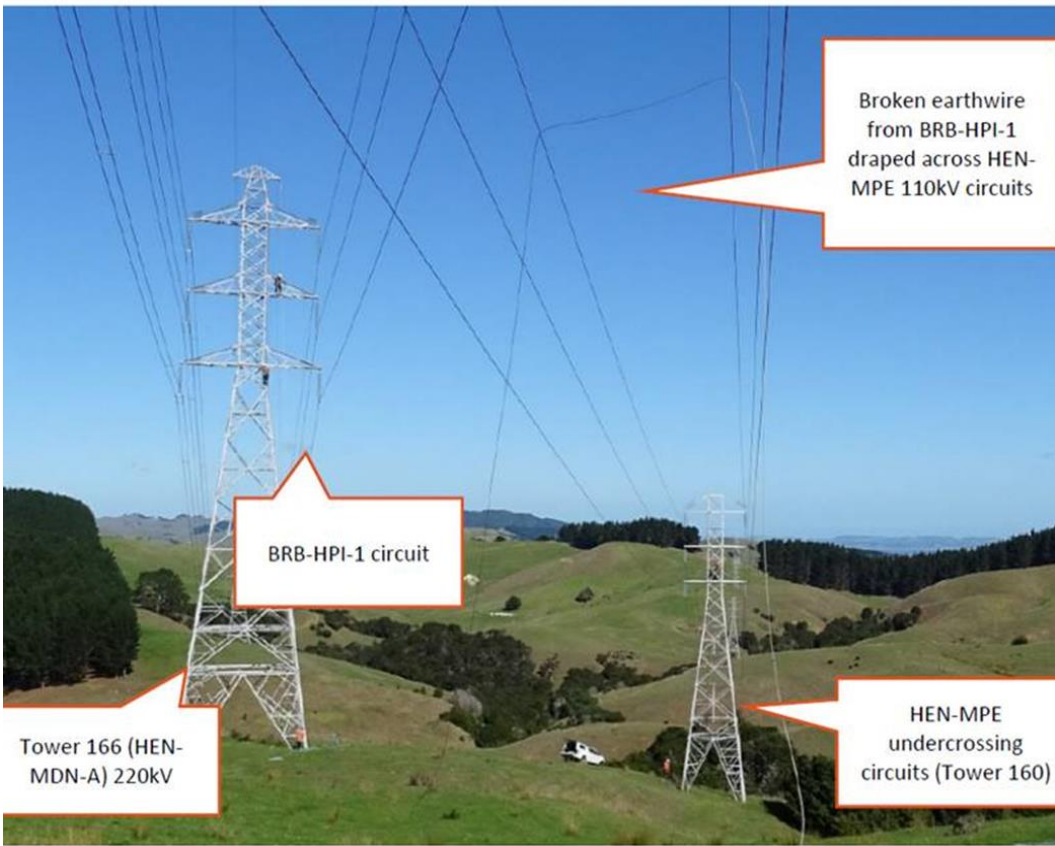
| Incident | | Description | |
|---|---|---|---|
| <b>What Happened:</b> | <p>Earthwire failed during preparation work for earthwire replacement project works, between Towers 166 and 167, on the 220kV BRB-HPI-1 Circuit (HEN-MDN-A).</p> <p>The earth wire fell coming to rest across an energised undercrossing, the 110kV Circuits (HEN-MPE-1 and HEN-MPE-2).</p> <p><b>Figure 1</b> Earthwire from BRB-HPI-1 draped across HEN-MPE 110kV circuits (photo taken in front of Tower 167)</p> | | |
| <b>Why it Happened:</b> | <p>HEN-MDN-A Skunk earth wire failed due to the tensioning of the conductor beyond its remaining mechanical strength.</p> <p>Significant contributing factors were:</p> <ul style="list-style-type: none"><li>• Earth wire was compromised due to an existing defect/damage at the point of failure. The previous damage was caused by clamping of the conductor with Kito Grips (or similar)</li></ul> | | |

| | <ul style="list-style-type: none"><li>• Poor rigging practice (distance between, resulting in excessive tension required to disconnect earth wire).</li><li>• No means of monitoring tension.</li></ul> |

| <b>What you must do in the future OR What will happen next:</b> | <ol style="list-style-type: none"><li>1. Rigging calculations and information must be made available to site crews, outlining everyday tension and importantly, the maximum tension that can safely be applied to any tension rigging systems. This should apply to all conductors.</li><li>2. Tension rigging systems should be placed in line with the conductor. In most cases, this can be achieved by rigging off a working point. If no working point is available, rigging shall be placed as close to the conductor attachment point as possible.</li><li>3. Any changes to rigging procedures / instructions must be approved by an qualified engineer.</li><li>4. Consideration to conductor grip selection should be applied and any conductor grip must be used in accordance with the manufactures instruction.</li><li>5. Dynos will be used in all conductor tension rigging systems to monitor actual tension against maximum tension.</li></ol> |
