Incident Alert

Wheel bearing collapse on Wood-chipper
(2010 Vermeer BC1000 Chipper P282U)

Thursday 31 June, 2014

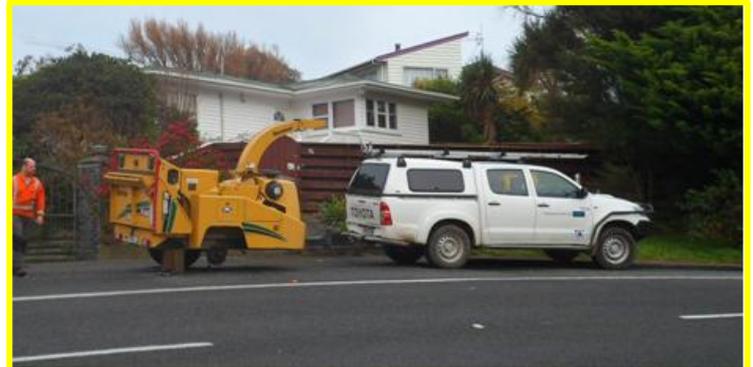
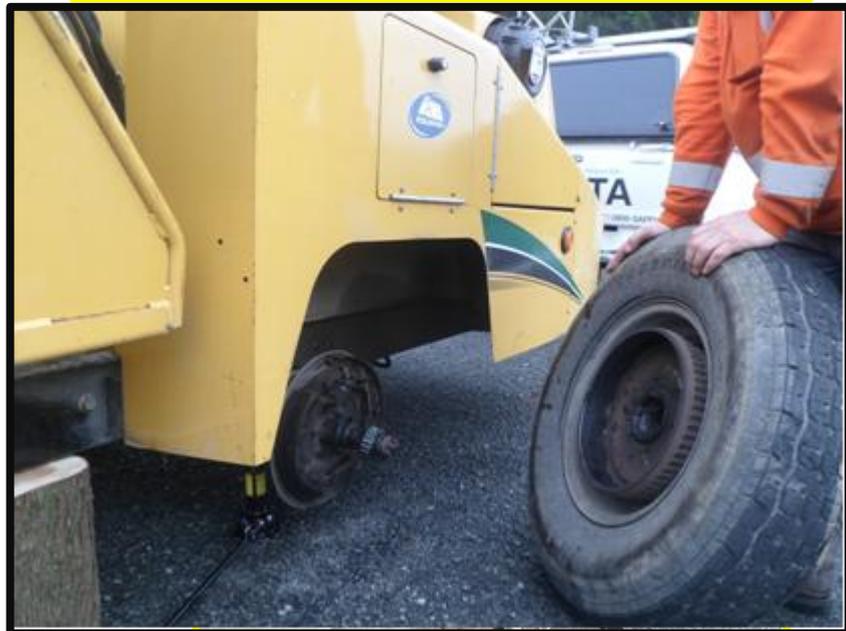
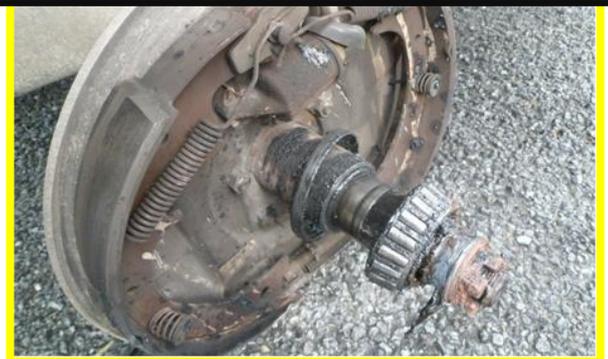
After it was jacked up it became apparent that the outer right wheel bearing had collapsed and there was damage to the stub axle.

- A better-way has been put-forward by the vegetation crew to undertake thorough machinery inspections three-monthly.
- The wood-chipper was within its Warrant of Fitness date and a pre-start inspection was carried out by the work crew prior to leaving the depot on the morning of 31/07/2014.
