# Safety Alert – SA402

## Asbestos Gasket on old CB Bushing

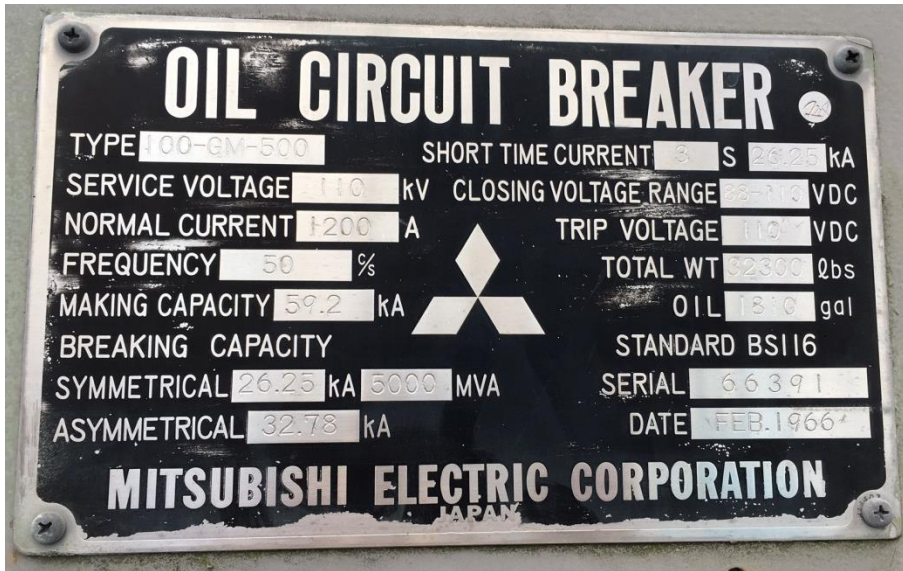
| Incident | Description | | |
|---|---|---|---|
| <i>Event Description:</i> | <p>After indication from the substation maintenance contractor that the old CB bushing oil has no service history and may contain PCB, Northpower had to reassess the methodology to scrap the CB as the scrap supplier would not take any contaminated oil. Further investigation on how to remove the bushing to drain the oil determined that the bushing also had a gasket with asbestos. CB Model as per below:</p> | | |
| <i>Potential Outcome:</i> | Failure to investigate the bushing components and get information from the maintenance team would have resulted on the project team working with asbestos materials and potentially PCBs (to be confirmed) | | |

| Incident | Description | | |
|---|---|---|---|
| <i>Actions Required / Messages:</i> | <p>Northpower stopped the removal of the bushing and will engage an Asbestos removal company to analyse the risks and to scrap the bushing safely. The oil on the bushing is being tested to confirm or discard PCBs.</p> <p>These risks were unknown to Transpower and Northpower at the beginning of the work which is the reason why they were not recorded on the Project Risk Register.</p> | | |
