# Safety Alert

Orion

## SA2409 - Low Voltage Distribution Box Overheating

18/07/2024

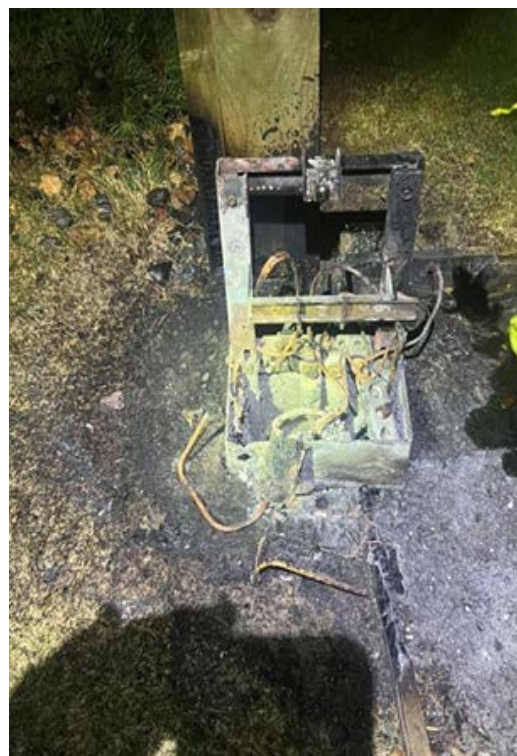
Since 2017 Orion has experienced several failures in our in-house designed Low Voltage (LV) distribution boxes, most of the failures have occurred at the Phase Connection Block (PCB). PCBs are a reducing termination block which in our solution is situated at the lower left-hand side of the distribution box.

Following investigations when these events occurred it has been observed that the failure could have been due to several reasons, i.e., improper installation practices, prolonged exposure to high moisture levels, or instances of water submergence affecting the connection block's integrity.

To address the failures, a solution was developed to remove the PCB from all new installations and replace it with a reducing termination.

- Orion has recently developed a new distribution box which aims to elevate the PCB. This will reduce water ingress compared to the current design where they are situated below ground level.
- The new distribution box has been designed to allow greater airflow and increased clearance between components. This helps to reduce the heating effects within the box and not allow moisture to accumulate.
