Date Issued: 21 July 2017

Incident Title: ICAM 45
Pole Collapse on 11 June 2017

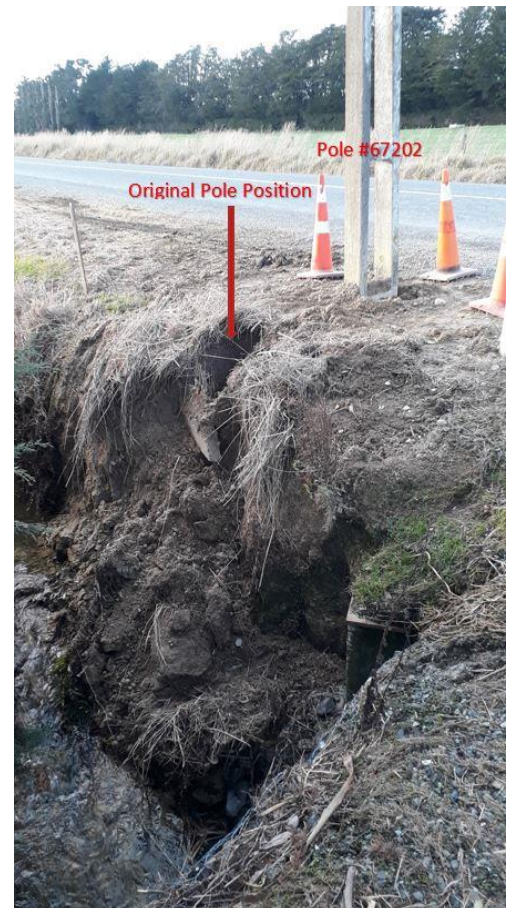
On 8 June it was brought to PowerNet's attention that a pole in Egerton Road, Winton, was leaning, allowing HV wires to sag close to a hedge running beneath the wires. The site was visited the next day and it was recognised that the poles proximity to a deep ditch, and the partial collapse of the ditch's bank, was allowing the pole to lean. The site was further complicated by being near a culvert and a road intersection. The situation was escalated to the distribution engineering team to identify a solution.

However, on 11 June, before a solution was identified and any remedial work could be carried out, the bank completely collapsed allowing the pole to lean, and the HV wires to contact the hedge, causing a small fire.

The pole was temporarily relocated, as shown in the photograph, until a more permanent solution could be found.

Reminder for all staff, particularly **asset inspection teams**, to note similar situations.

Section AP-02 of **FOHA-005 Overhead Lines Inspection Handbook** highlights the issues around pole leaning, excavations near poles, exposed breast blocks, natural soil movement, insufficient pole embedment, and the steepness of the ground at the base of a pole.

Asset inspection teams must assess all sites for these issues and record their assessment on the asset condition report to ensure remedial action can be given the appropriate priority.
