## Arteche CH-123 CT Failures - Update

Transpower has had five Arteche CH-123 2011 model CT failures since October 2018 including a recent failure of HAY CT-142 on Saturday 30 November 2019.

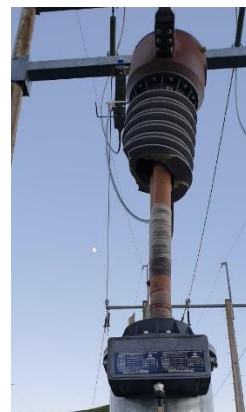
It has been confirmed, via a forensic inspection with the manufacturer's representative, that the failure mode of these CTs is associated with moisture ingress from the top rubber bellows. Subsequently, the rubber bellows were inspected and Dissolved Gas Analysis (DGA) tests were carried out on the entire in-service fleet of CH-123 and CH-72 CT's. Based on the inspection/DGA results and following the manufacturer's DGA guidelines, a prioritised replacement program was developed. As a precaution, a 10m exclusion zone was initiated around these CTs at that time.

Following the failure of HAY CT-142 at the weekend the following actions are to be implemented immediately.

At this time, we ask that everyone working at sites near these Arteche CT's exercise caution and ensure that Safety Plans and Work Plans take account of the potentially elevated risk associated with all Arteche CH-123 and CH-72 CTs. We recommend the following precautionary steps be taken:

- The following Arteche CH-123 CT's are to have a roped off exclusion zone of at least 10m established immediately at:
