## Incorrect Vibration dampers

Quality Alert REF No : 2018-001

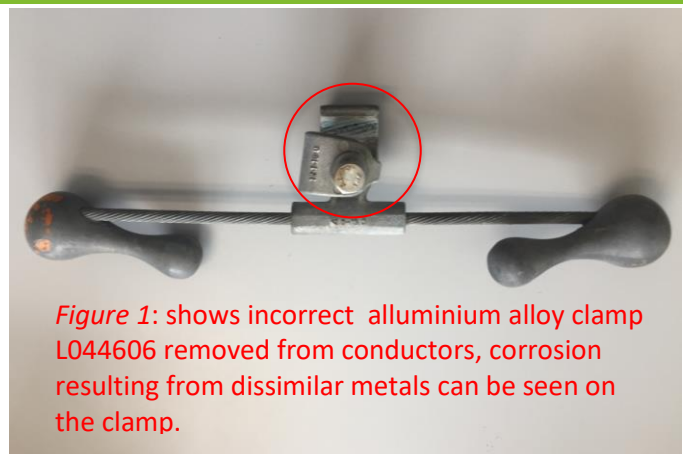
A crew sent to repair a vibration damaged conductor with broken conductor strands near clamp on GOR-HWB A pole 173, identified significant corrosion of the conductor under the vibration damper clamp.

Dampers were removed from all 3 phases to prevent further deterioration, and were found to be **incorrect** damper stock code L044606.

The **correct** damper stock code for 19/2.34 Copper diameter 11.68mm is L044620

*Figure 1: shows incorrect alluminium alloy clamp L044606 removed from conductors, corrosion resulting from dissimilar metals can be seen on the clamp.*

- The correct dampers for copper conductors have conductor clamps made of a steel alloy (L044620) as opposed to the aluminium alloy (L044606) for the other conductors types
- A review of historical scanned QA records indicates that most of the incorrect vibration dampers were installed by projects in the mid to late 1990's
- Incorrect Damper stock code L044606 does not exist in Maximo or in any stock lists
- Some installations around this time did not comply with now superceded TP.ML 03.26 Installation of Vibration Dampers

Transpower requires the correct vibration damper clamps to be used

- Desktop analysis of CA photos showed mostly steel alloy damper clamps on GOR-HWB
- However Poles 176 and 197 appear to be alloy and will be checked on next patrol
- Teams are reminded to ensure dampers are installed in compliance with TP.SS 02.16 which specifies :
  - Damper Stock Code L044620 – for Copper conductors
  - Damper Stock Code L044606 – for ACSR conductors (coyote 15.89mm to skunk 12.95mm)
- This alert is to remind maintenance and project teams to ensure correct damper stock code is used

- All Service Delivery Managers, Project Managers, and Service Providers must report any instances they come across, where dampers with aluminium clamps have been incorrectly fitted to copper conductors. It is essential that all dampers are selected, installed and maintained in accordance with TP.SS 02.16 Installation and maintenance of conductor, conductor accessories and aerial communications cables.
