TRANSPOWER

FIRST ALERT

IMS Reference: INC#119349

Failed strop causing redundant bushing to drop

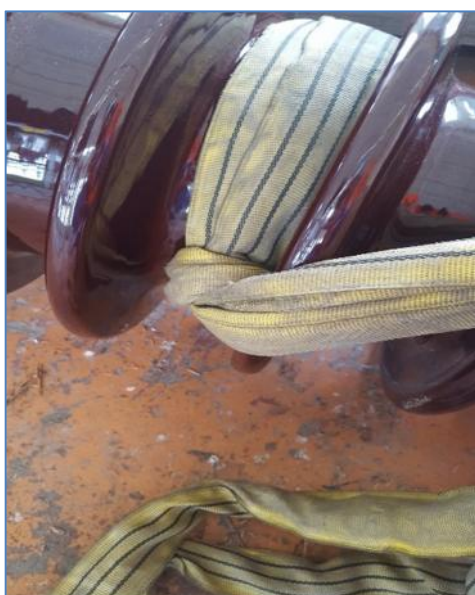
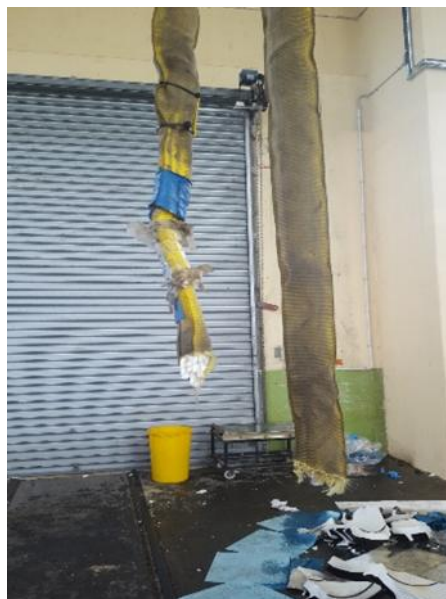
While using an overhead crane to lift a redundant 220kV transformer bushing to drain the oil before scrapping, the strop used to lift the bushing failed resulting in the bushing dropping a short distance (100mm) to the ground.

The bushing was rigged with a single strop (choked), which was correctly rated and certified.

No injuries were sustained and there was no damage to other equipment.

- Broadspectrum management and Transpower were informed, the scene was quarantined and made safe to allow an investigation to begin.
- The oil spill was contained with minimal disruption to the incident scene.
- All lifting tasks were halted until the procedures were reviewed.
- On completion of investigation, further updates will be circulated to all Service Providers.
