SAFETY ALERT

REF. NO: **HSE008/17**

DATE OF ISSUE: **05/09/2017**

HISTORY – WHAT HAPPENED

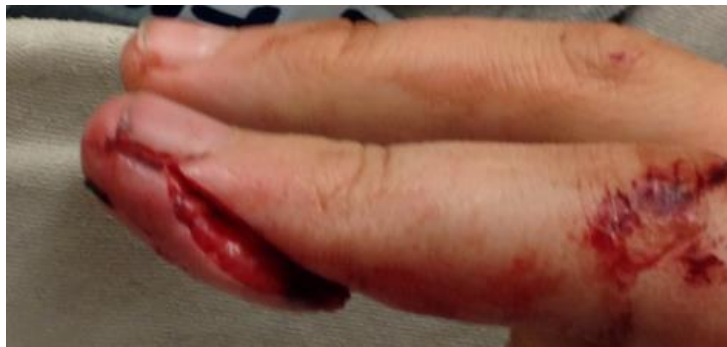
In August 2017, a member of the public tripped and fell next to a power pole. During the fall the person's finger contacted a stainless-steel cable support strap on the pole resulting in a laceration. The person was taken to hospital for surgery.

1. The pole cable strap was a Utilux Stainless steel strap 12.7mm.
2. This strap ties and supports PVC cable conduit from the ground to a height of approximately 9 meters.
3. The stainless steel strap is smooth along the length and the ends are sharp due to the cutting of the band.
4. The strap had a cut length beyond the foldable tags.
5. A longer cut length can occur when the cutting tool slips down the length of strap slightly during the cutting action.
6. The longer cut length can result in the cable strap protruding from the pole.
